NEW RENOVATION TO THE SECOND FLOOR OF A 2 STORY BUILDING. THE SECOND FLOOR IS 3,318 SQ. FT. WITH BRICK EXTERIOR WALLS, WOOD FLOOR JOISTS AND STEEL BEAM FLOOR SUPPORTS. THE FIRST FLOOR IS CURRENTLY AN EXISTING CHINESE RESTAURANT.

Property address: 456 Broadway, Monticello, NY
Assessment report date: June 23, 2015
Site inspection date: June 17, 2015
Prepared by: Gregg DeAngelis, AIA
Scope: The scope of this assessment is to identify existing structural issues which would impact the redevelopment of the building. The condition of key building systems and materials has been summarized.

EXISTING CONDITION PHOTOS

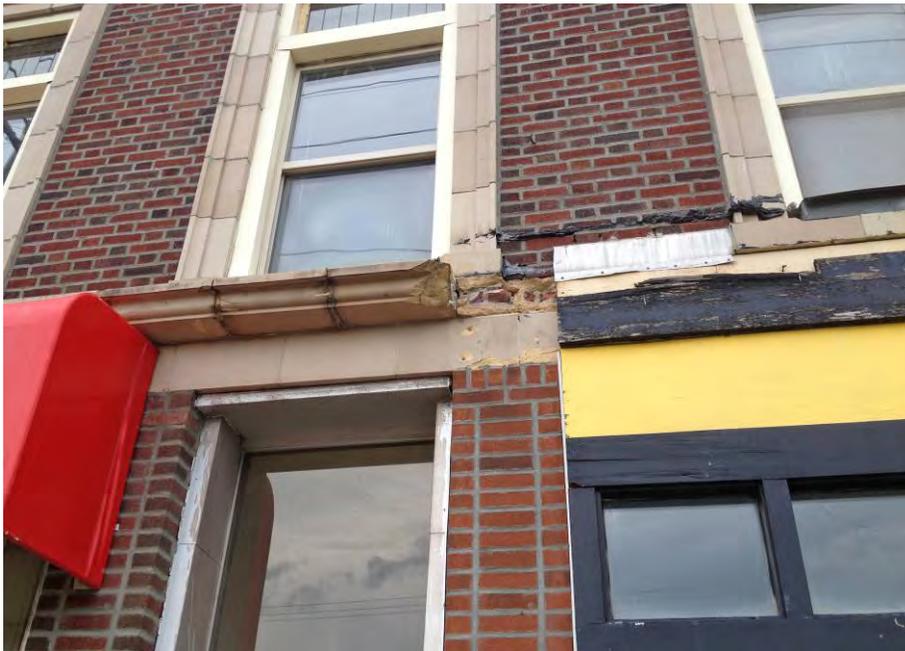
Walls: The existing building is finished with a combination of brick veneer and stucco. Brick has recently been repointed throughout. Stucco has been installed over existing masonry on the east and west elevations. Masonry and stucco are in good condition throughout. Existing terra cotta accents and decorative details on the south (Broadway) elevation were damaged when signage and storefront systems were installed. Terra cotta is chipped or has deteriorated in numerous locations.

Damaged terra cotta

Recommended repairs: Replace deteriorated terra cotta with similar masonry materials. Inspect and repoint brick veneer masonry. Repair or replace damaged double hung windows and restore ornamental transoms on second floor.

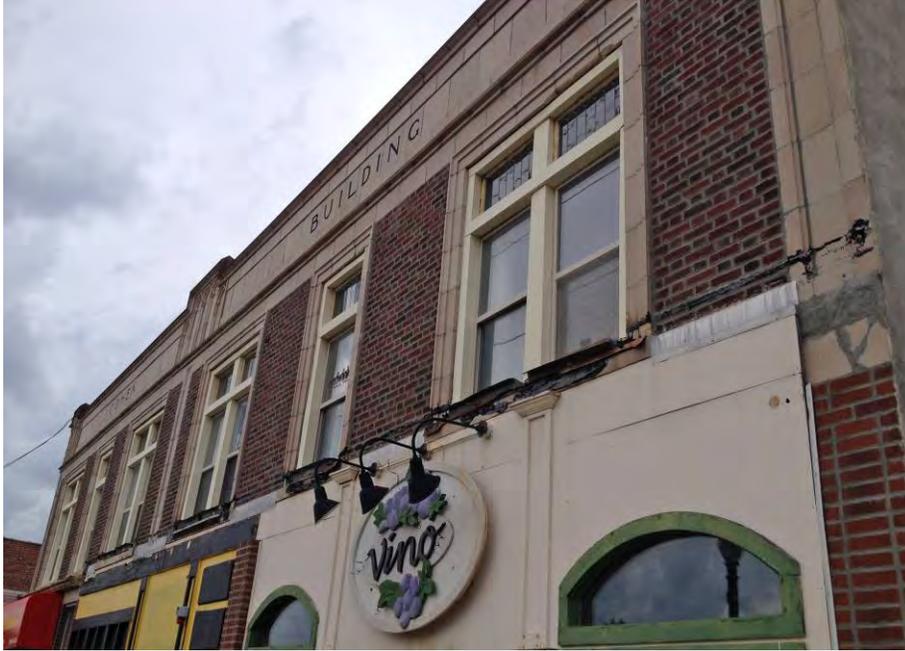
Damaged terra cotta

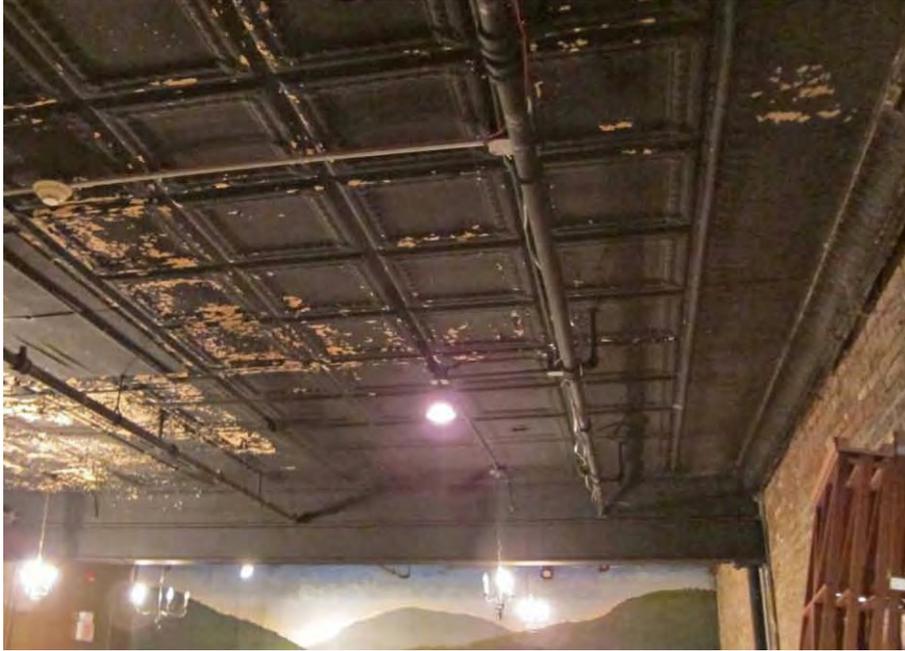
Ceilings: Existing first floor ceilings are a combination of pressed tin and 2x4 suspended acoustical tile in fair to poor condition. Existing second floor ceilings are typically 2x4 suspended acoustical tiles in fair condition. Several second floor office ceilings are of plaster on wood lath construction. Plaster ceilings have cracked in some locations. These cracks could be the result of prior water infiltration or settlement over time.

First Floor – Pressed tin ceiling
(photo courtesy of Sullivan County Division of Planning)

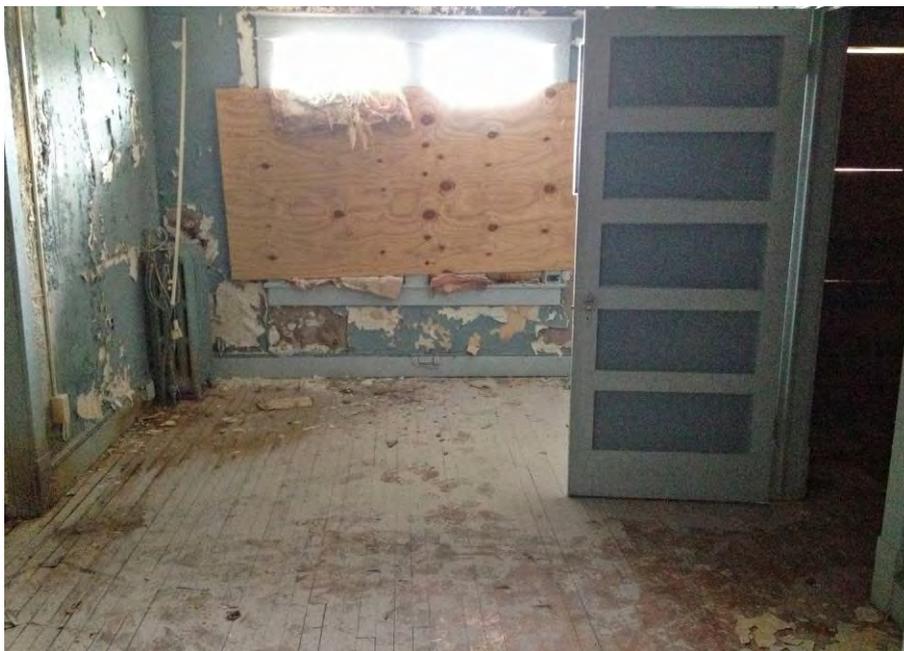
Floors: Finished wood floors have buckled throughout due to water infiltration. Resilient flooring is in fair condition. Carpeting is in poor condition. Ceramic tile flooring is in good condition. The finished floor elevation of one first floor tenant is elevated above the sidewalk level approximately six (6) inches.

Second Floor – Damaged plaster and wood floors

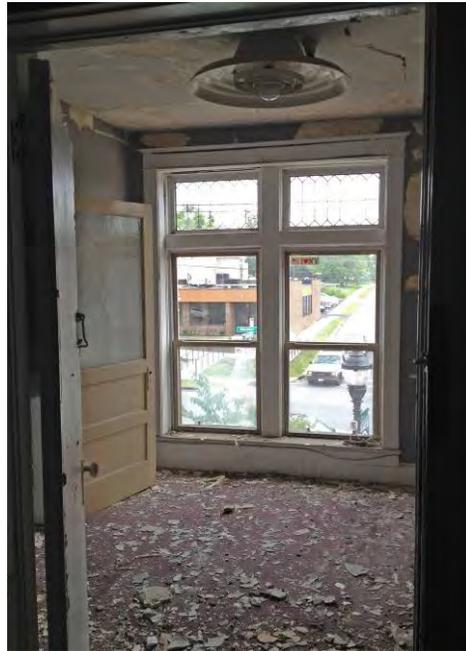
Second Floor – Damaged paint and carpet

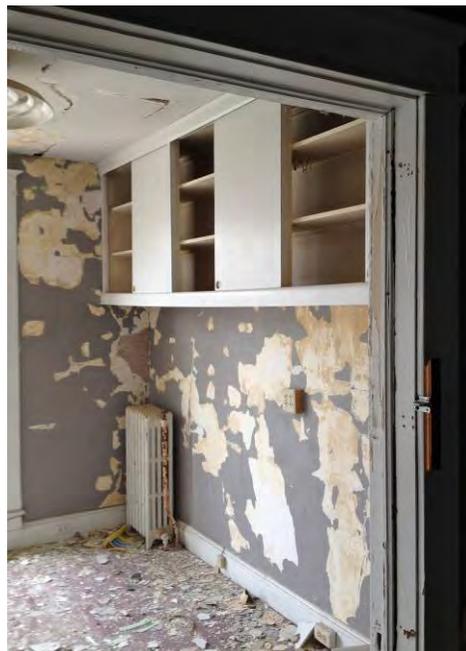
Walls: First floor walls are a combination of plaster on wood lath, gypsum board, and exposed masonry in good condition. Second floor walls are typically plaster on wood lath in good condition. It should be noted that painted finishes are peeling or delaminating throughout. This is assumed to be caused by variations in building conditioning over time due to vacancies and prior water infiltration.

Second Floor – Peeling paint

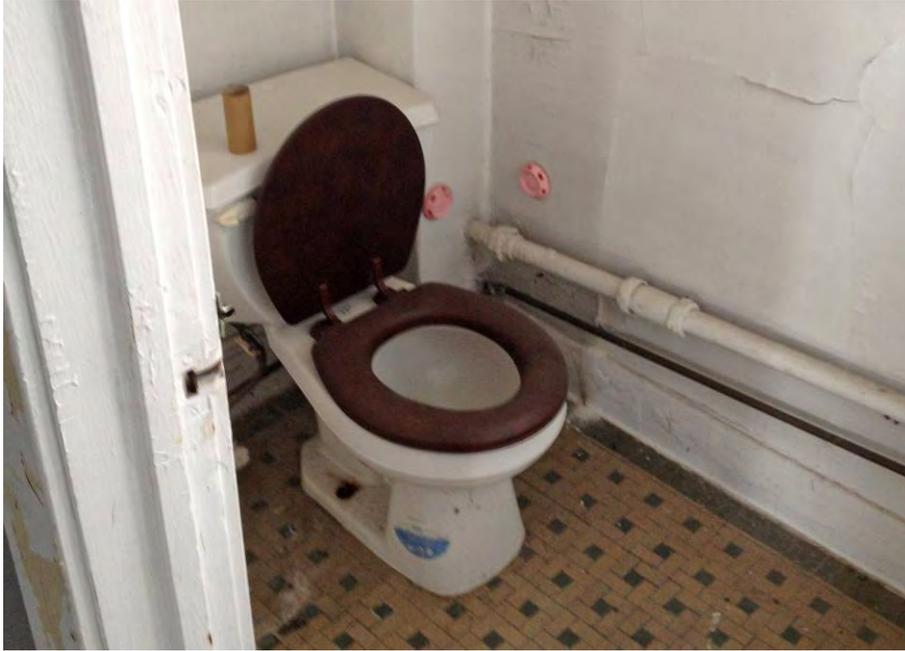
Fixtures: Fixtures and fittings are typically in poor condition.

Second Floor – Toilet room

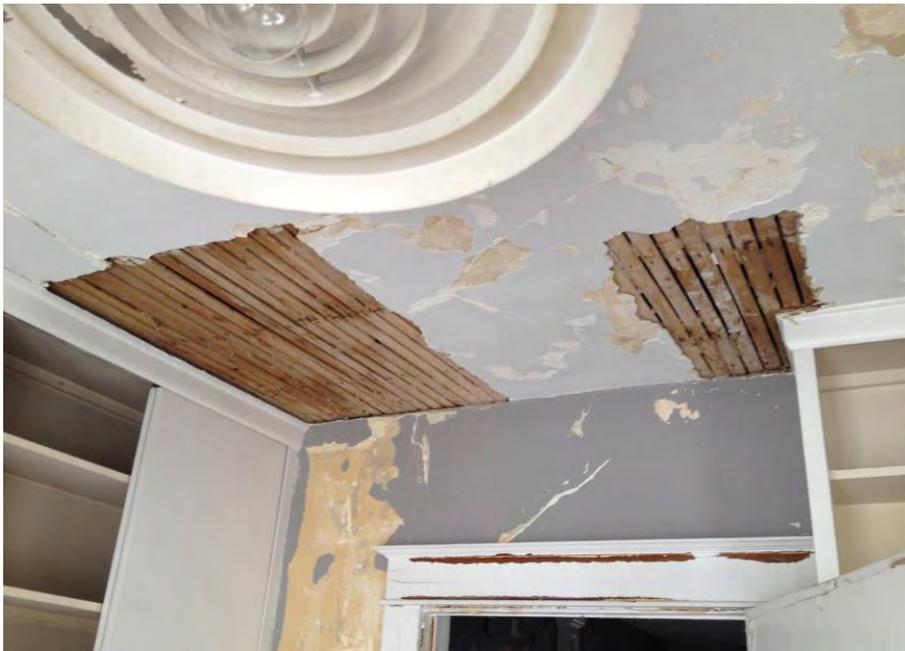
Second Floor – Damaged plaster ceiling
