# NY MAIN STREET PROGRAM

The Kirkland Hotel and Uptown Kingston

The uptown Kingston historic district is referred to as the Stockade District. Historical significance of the area dates to the revolutionary war period. Mall development in the town of Ulster over the last 30 years have aided to the decline in investment of retailers in this area. The following photos will be in tour order

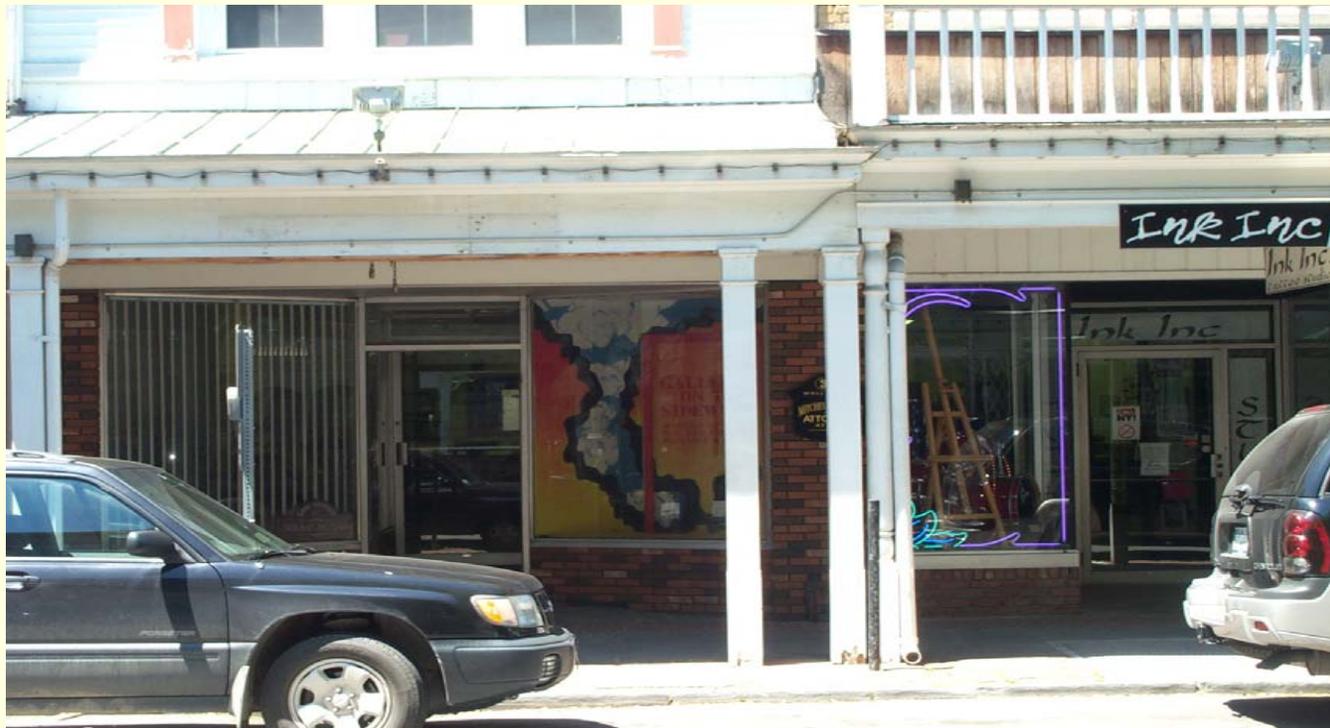
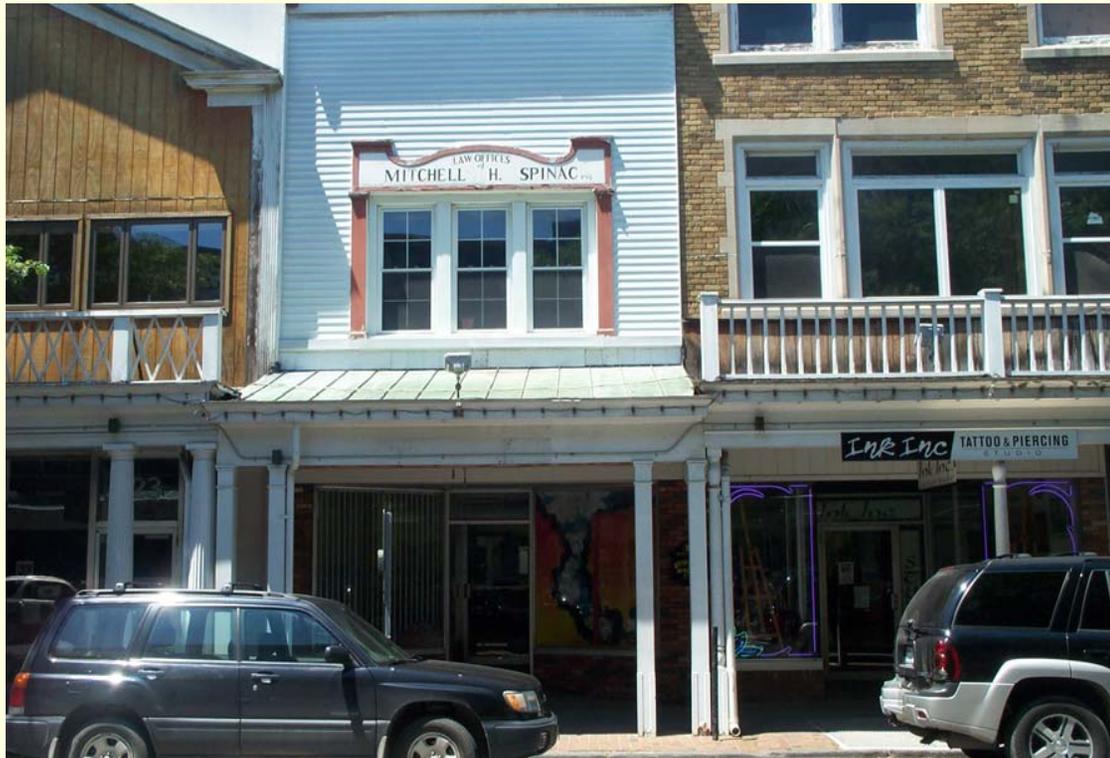
Original plan was to remove artificial brick and vinyl siding and to restore sign and install new glass and glass doors, EXAMPLE OF NON COMPLIANCE PROJECT – CONTRACTOR DID NOT INSTALL AS PER APPROVED PLANS- IN MITIGATION TO RESTORE TO ORIGINAL WINDOW SIZES

PHOTOS OF NON CONFORMING PROJECT IN PROCESS  
DOOR AND WINDOW HEIGHTS WERE NOT MAINTAINED  
APPLICATION OF WOOD CLAPBOARD IN PLACE OF VINYL WAS GOOD  
MITIGATION IN PROGRESS TO CORRECT WINDOW HEIGHTS/WIDTHS

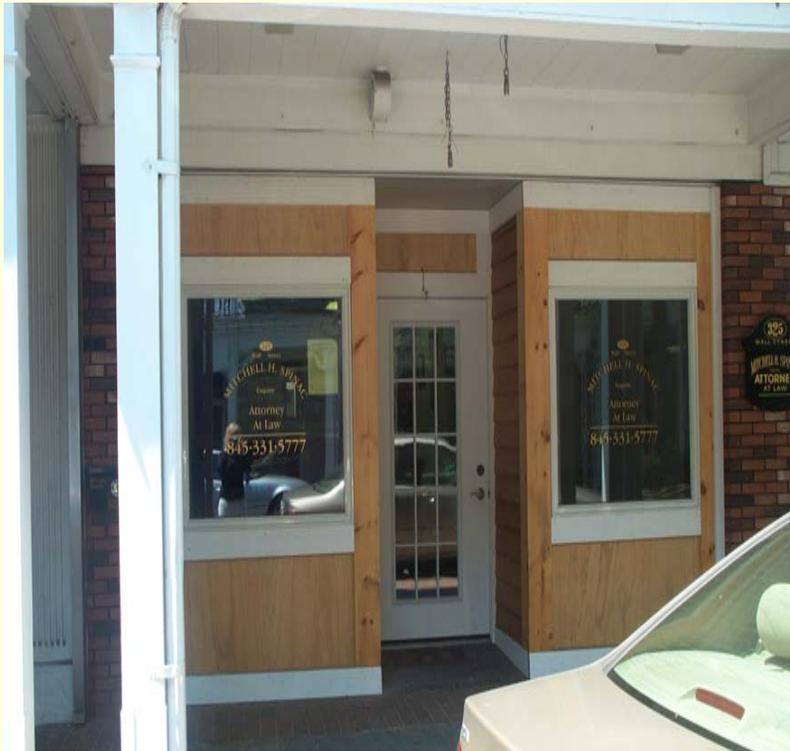
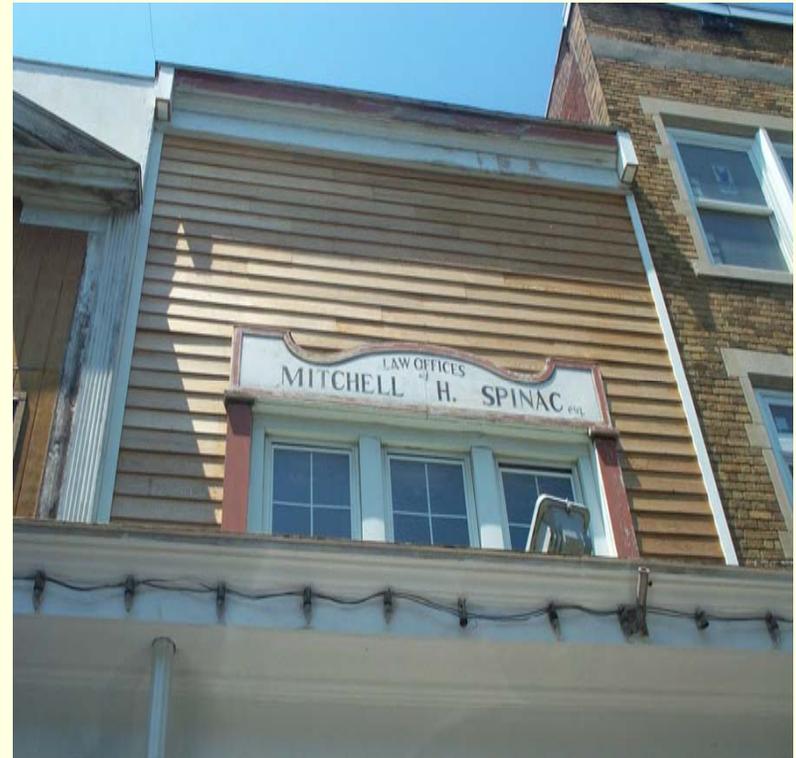
- In Mitigation to correct window openings and entry curve. Good clapboard from vinyl replacement

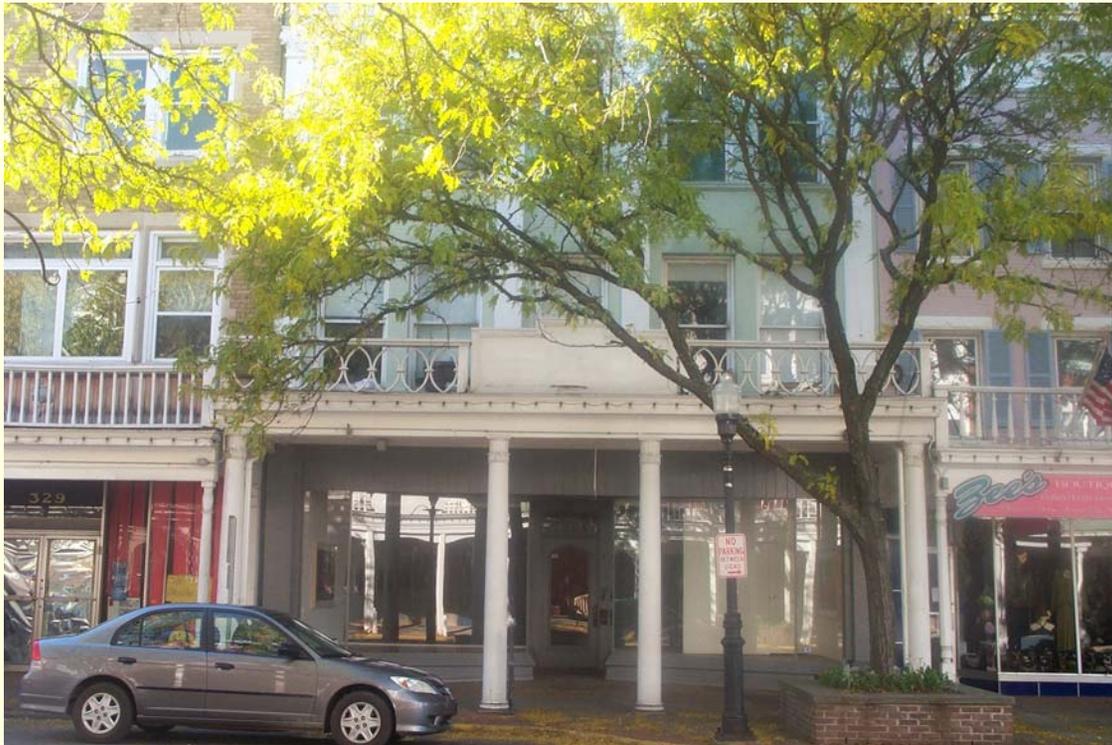
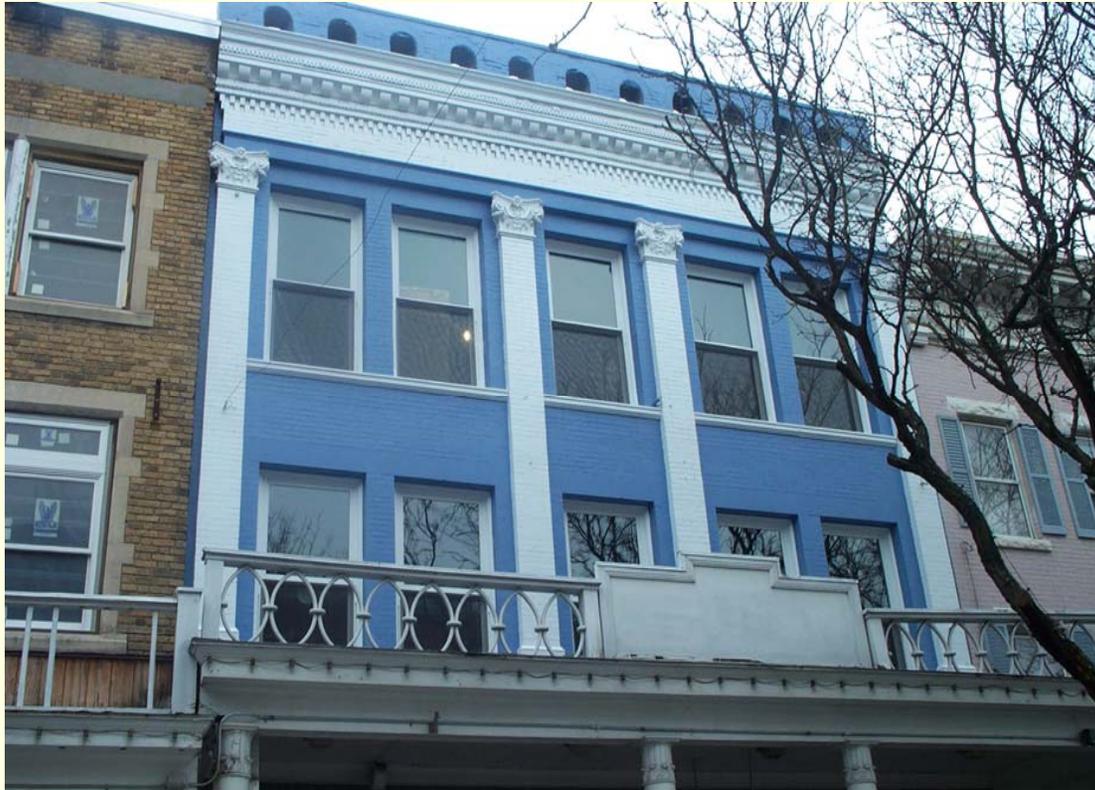
331 Wall St. Jeffrey Milstein

New Historic wood Windows replacing vinyl windows, Paint Job on upper level of building

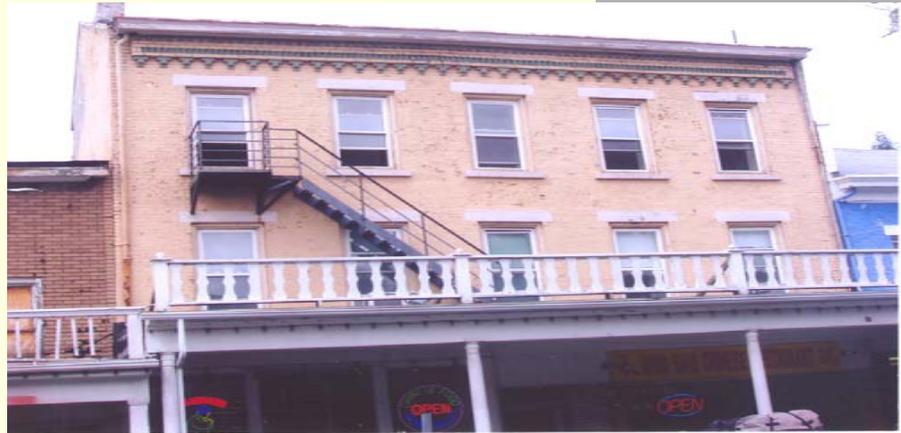
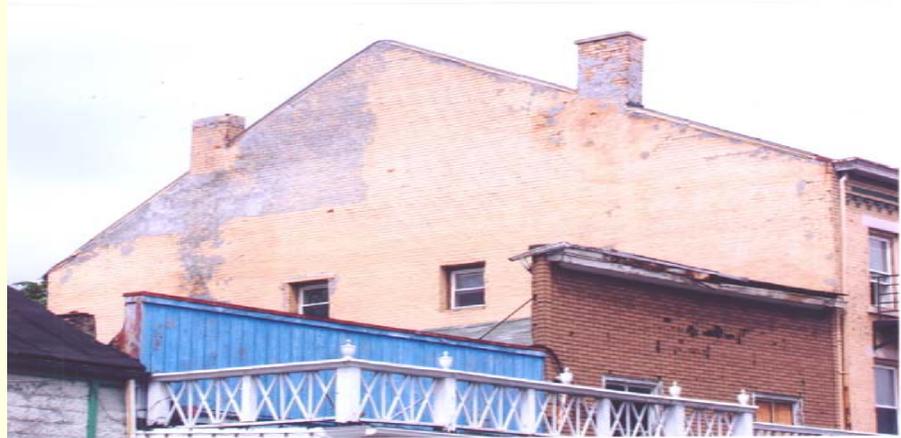
■ before

53 North Front St. Shui Kin Lam- Chinese Restaurant  
Grant Amount \$ 2,150 Owner Amount \$ 2,150  
Painting and scraping of upper side and front of building

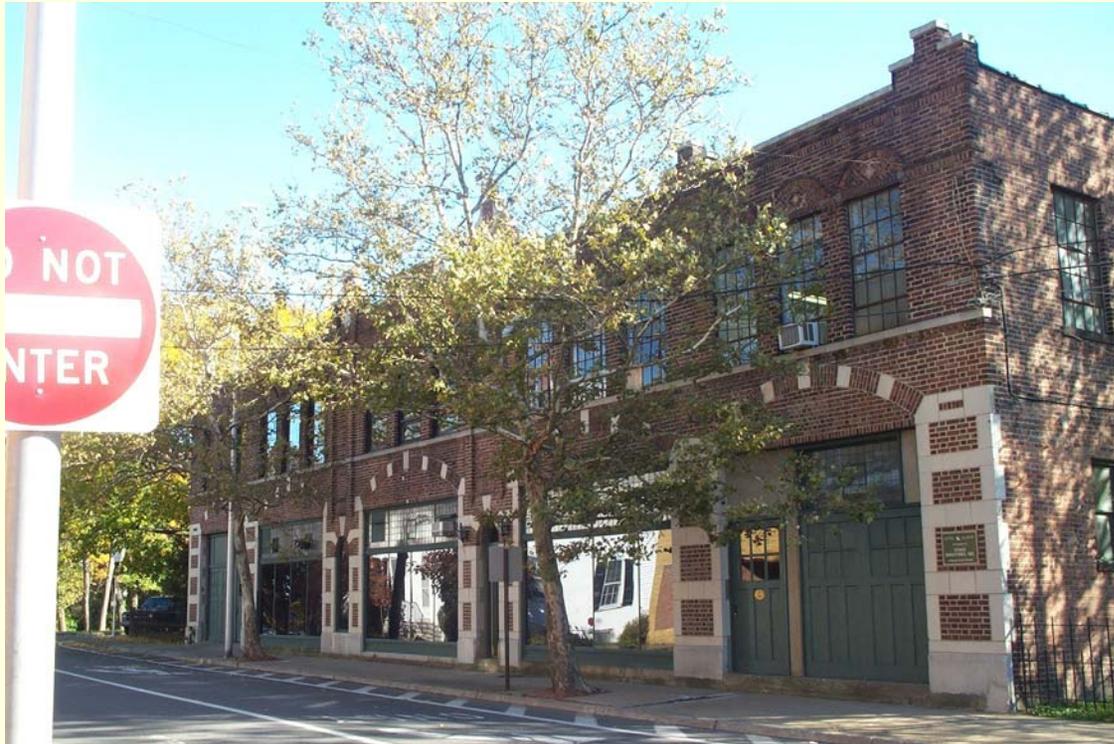
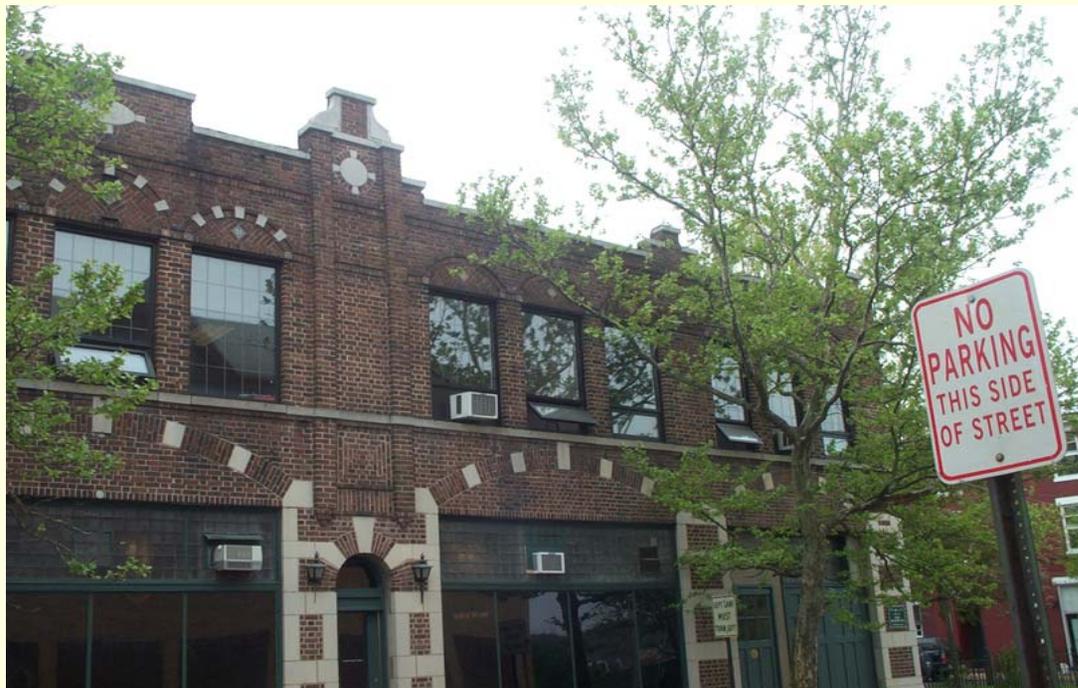
8 North Front Street – Industrial office Stavo Industries

New historically correct industrial windows to replace old metal factory windows

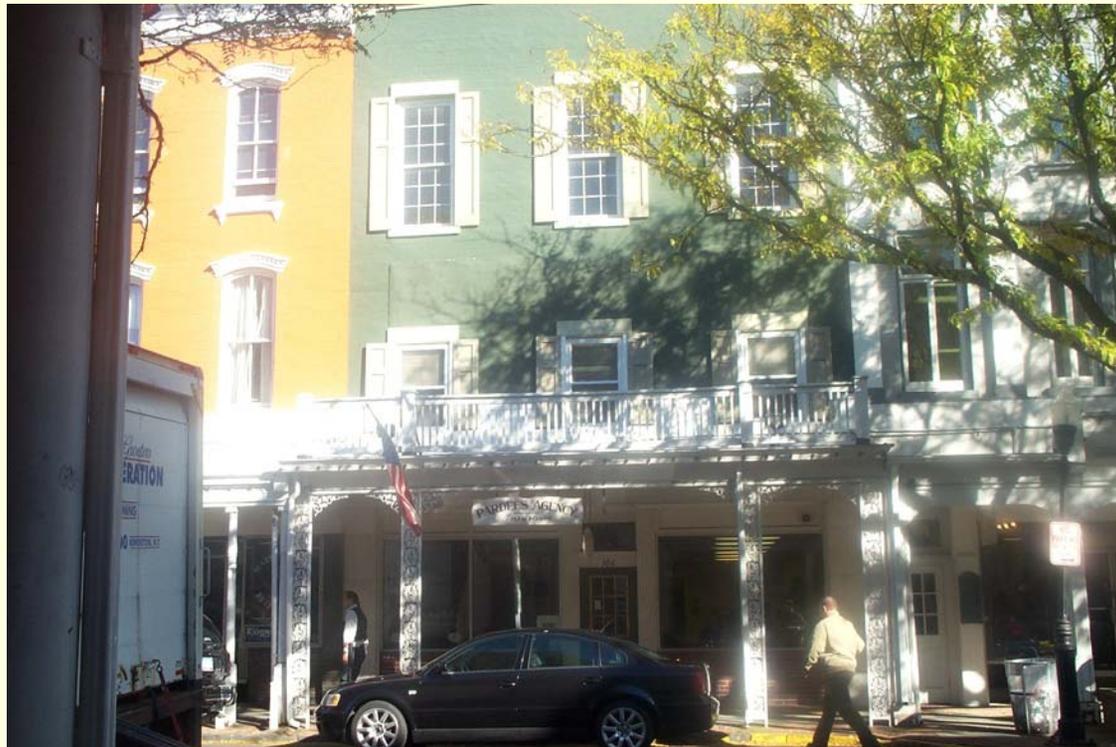
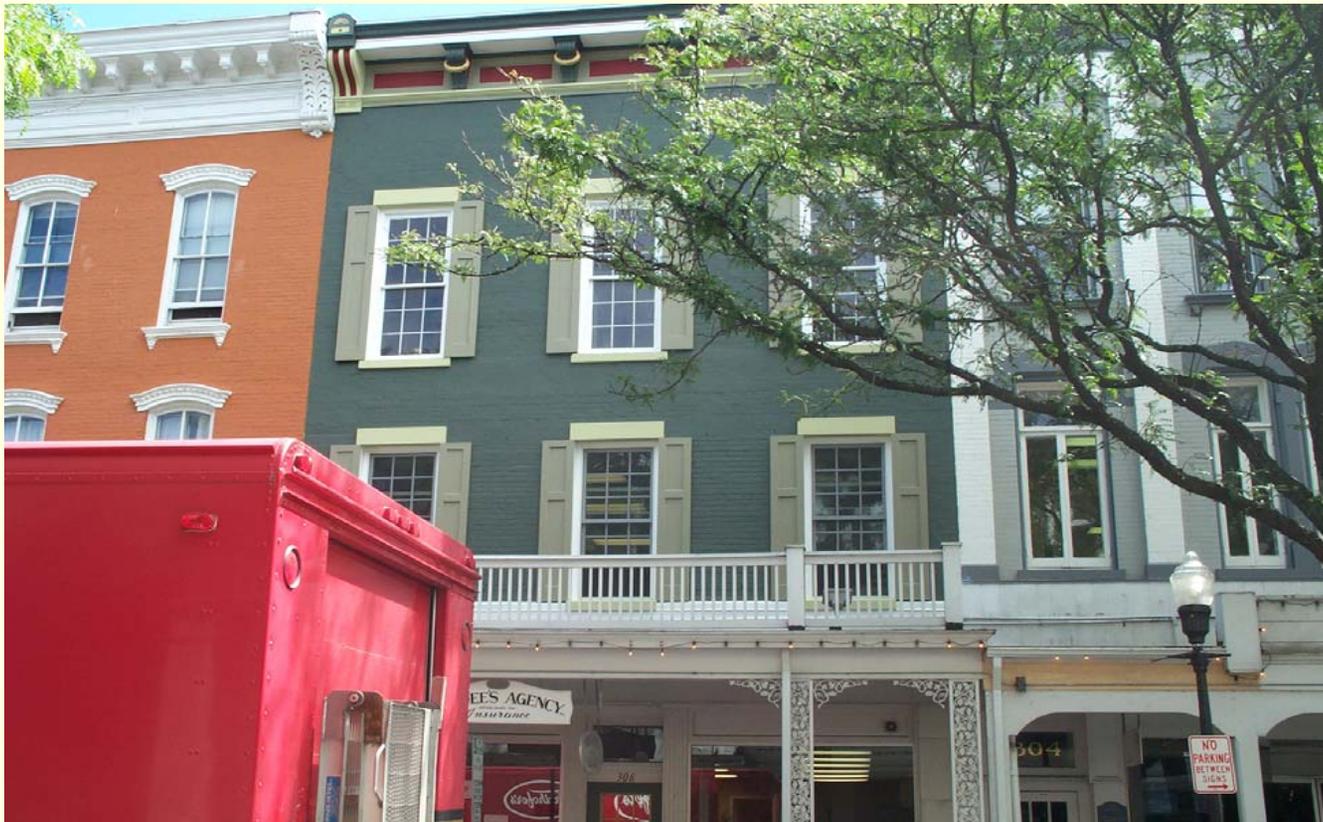
306 Wall St. Barbara Buddenhagen and Penny Ducker – Insurance Agency

Opened windows back up to original size , installed wood historically approved windows , including painting and matching of shutters

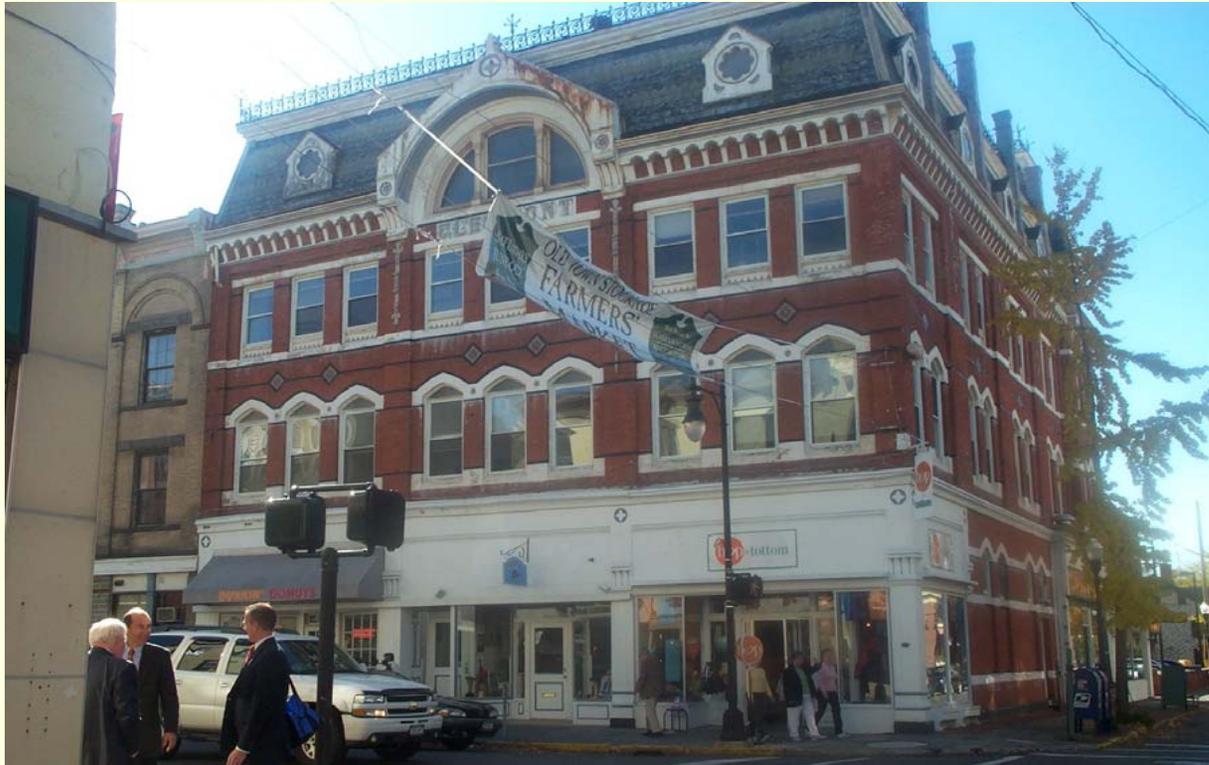
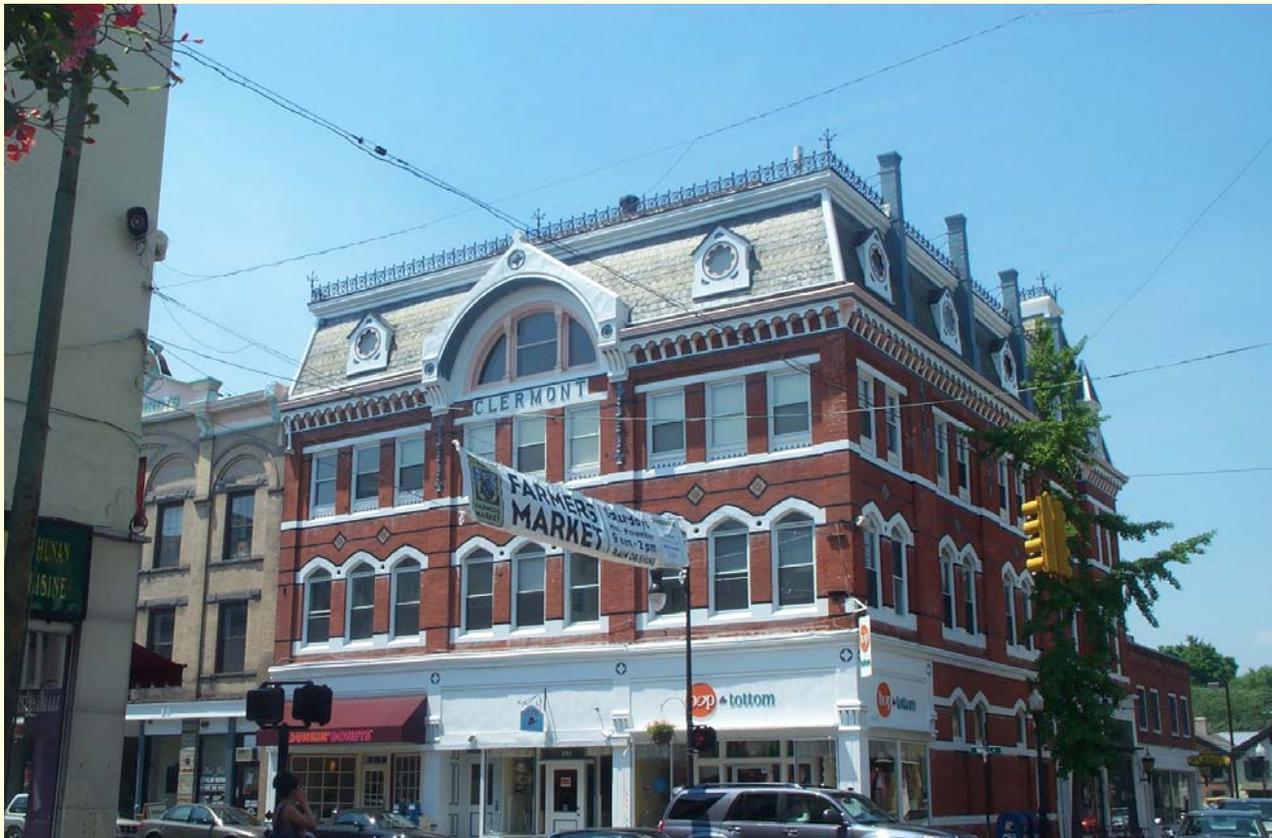
291-299 Wall St. Bleecker Grove Associates ( Dunkin Donuts and Bop To Tottem)  
Grant Amount \$ 10,000 Owner Amount !0,000  
Entire point work of masonry and repaint of trim

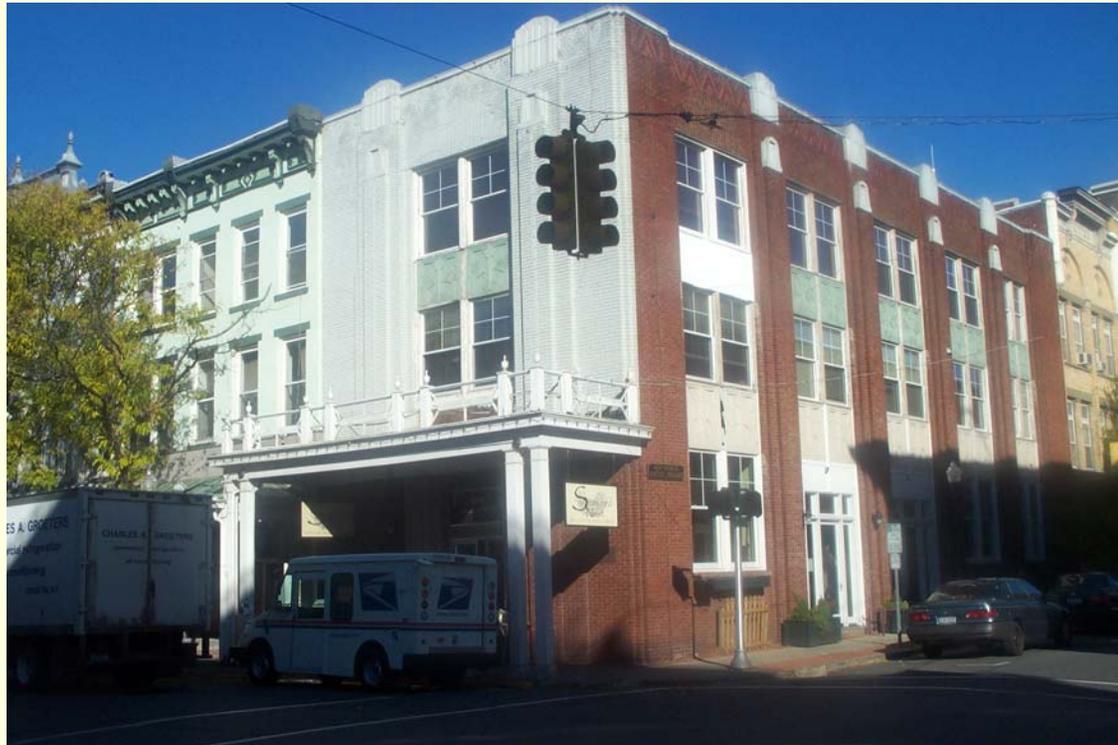
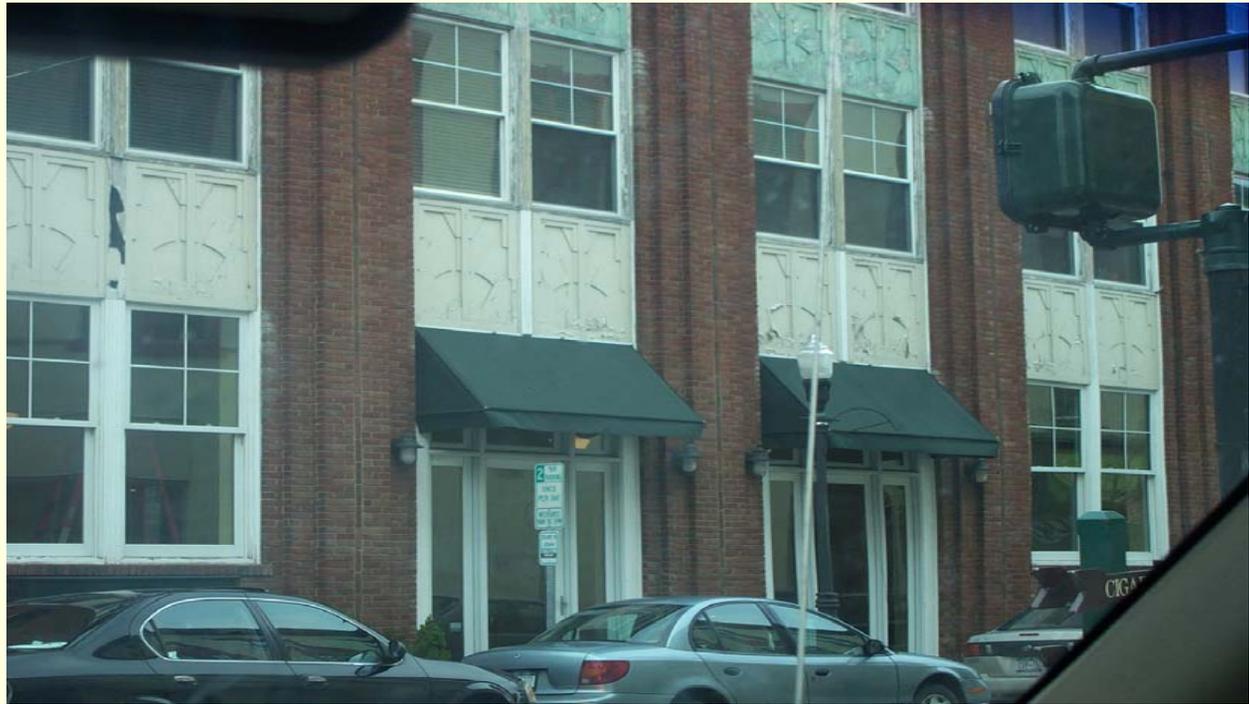
Awnings- Project was pull out due to forced sale, original work not completed

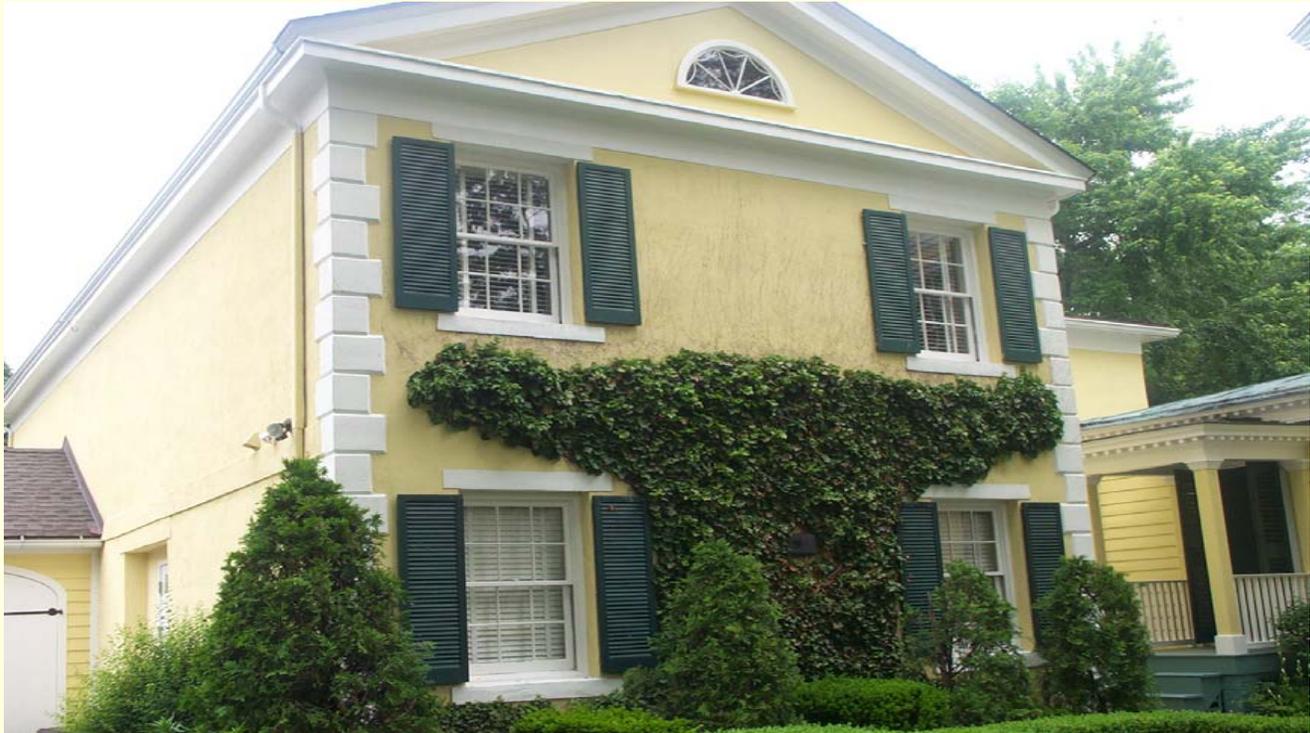
## ■ AFTER

Scraping and Painting

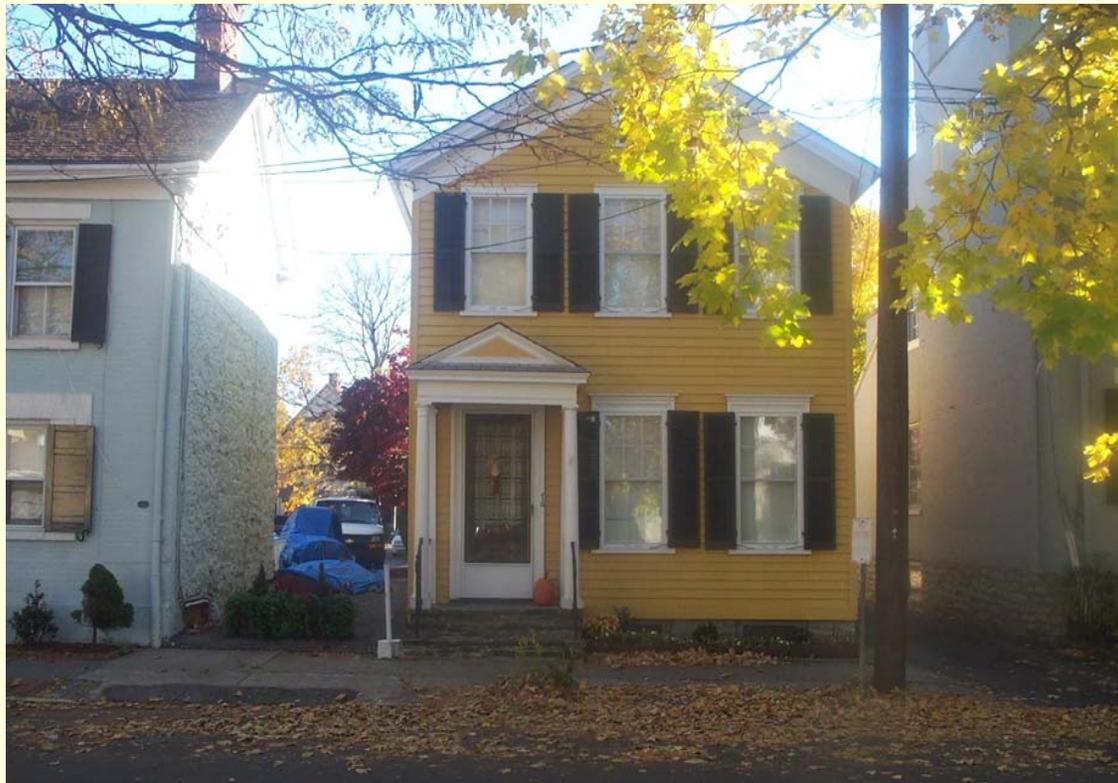
## ■ BEFORE

Period wrought/cast iron decorative fencing, shutter replication, lighting

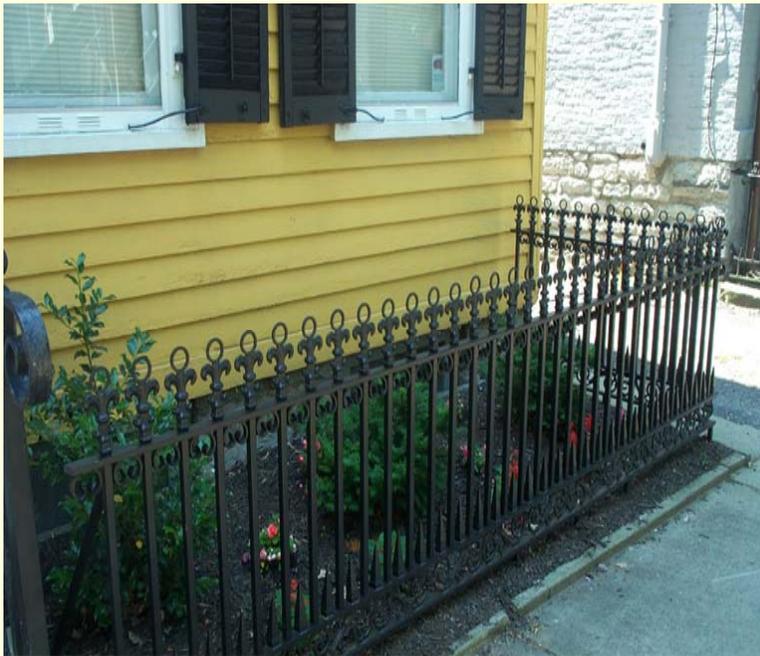
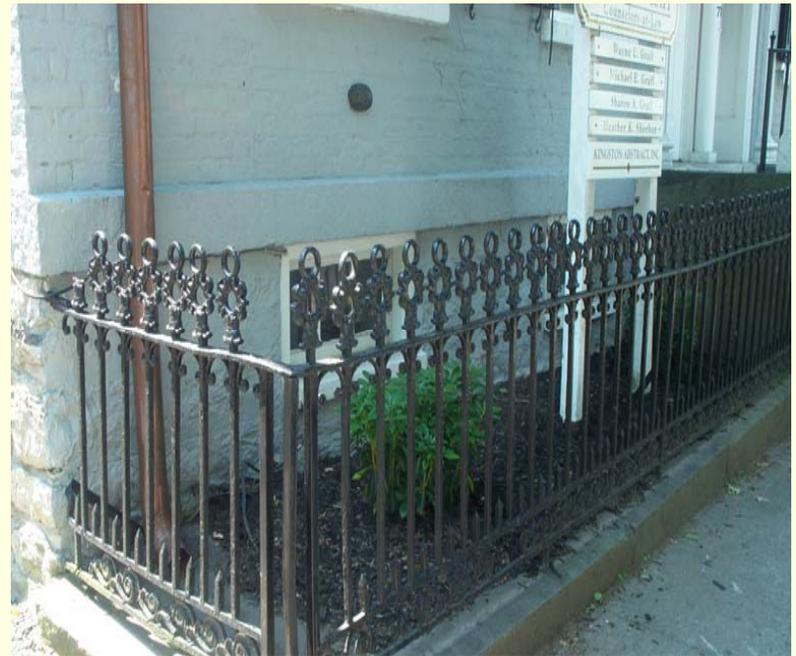
Left is new fencing, Right is original wrought iron and cast fencing shown on neighboring building . Complete duplication is not desired as we are attempting to integrate not replicate.

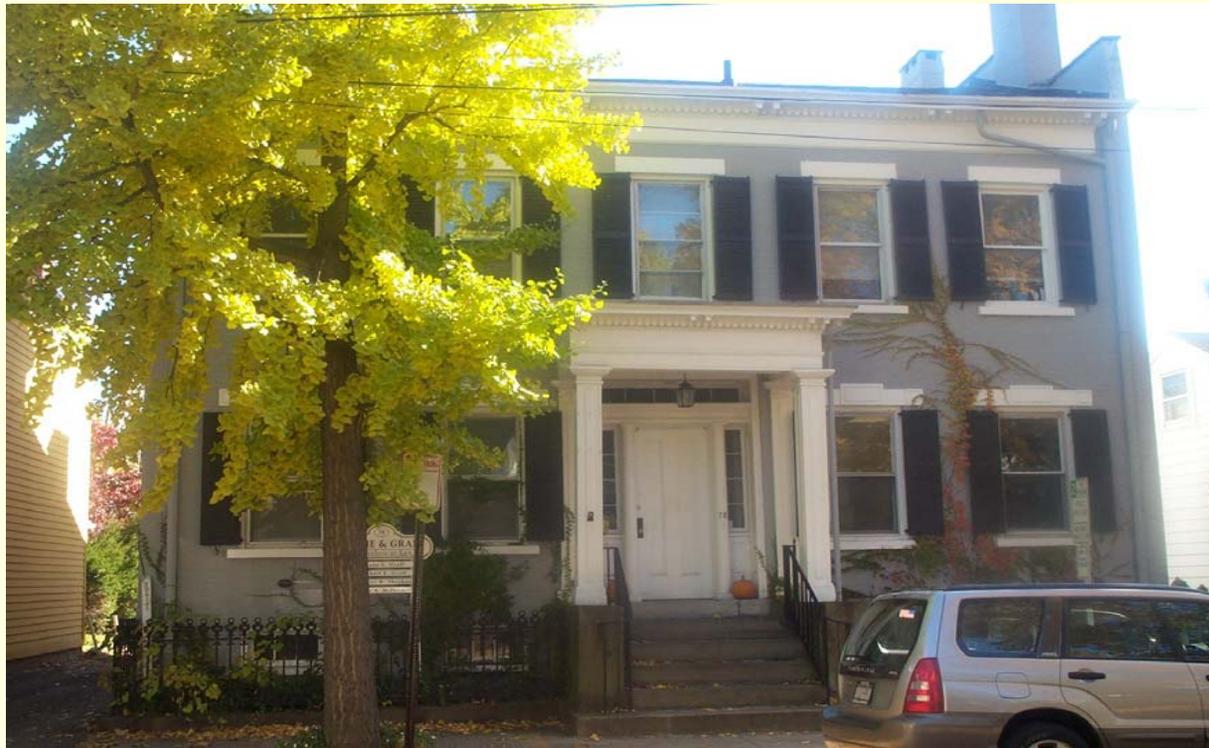
## ■ BEFORE

Historic protective storm windows, copper gutter work

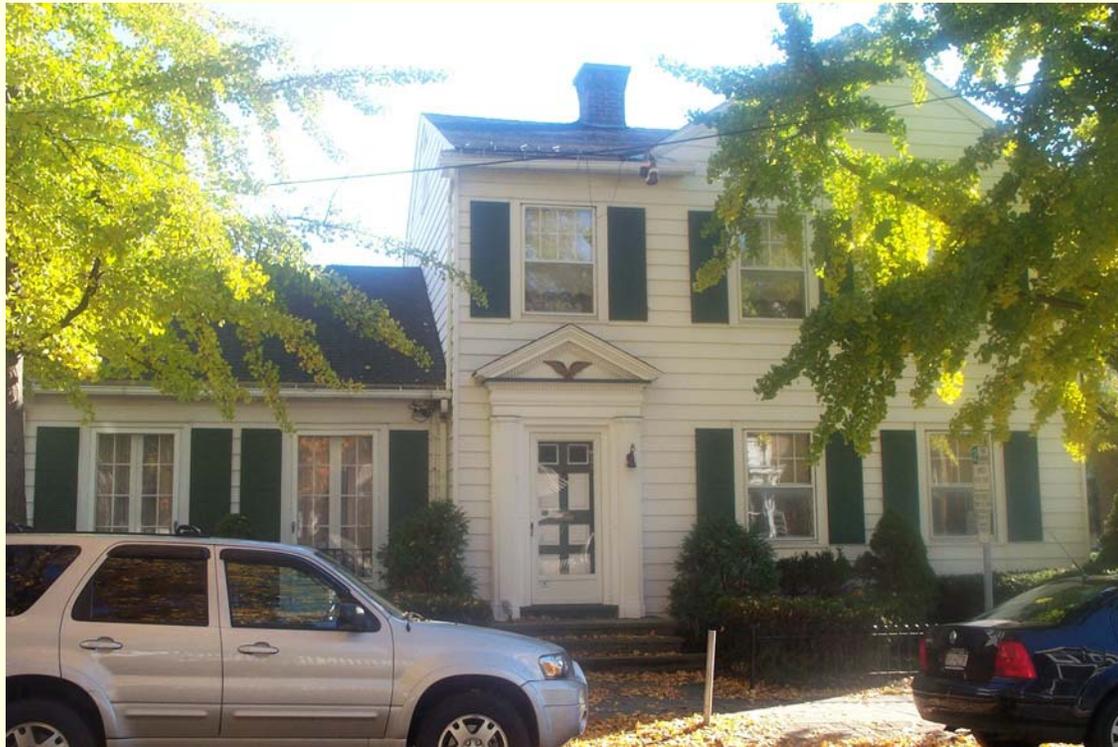
## ■ AFTER

Trim and Shutter paintjob and stove step work ORIGINAL PHOTO NOT AVAILABLE ON COMPUTER FORMAT. ORIGINAL COLOR WAS LIGHT LIME GREEN, CHANGED COLOR TO HUNTER GREEN.

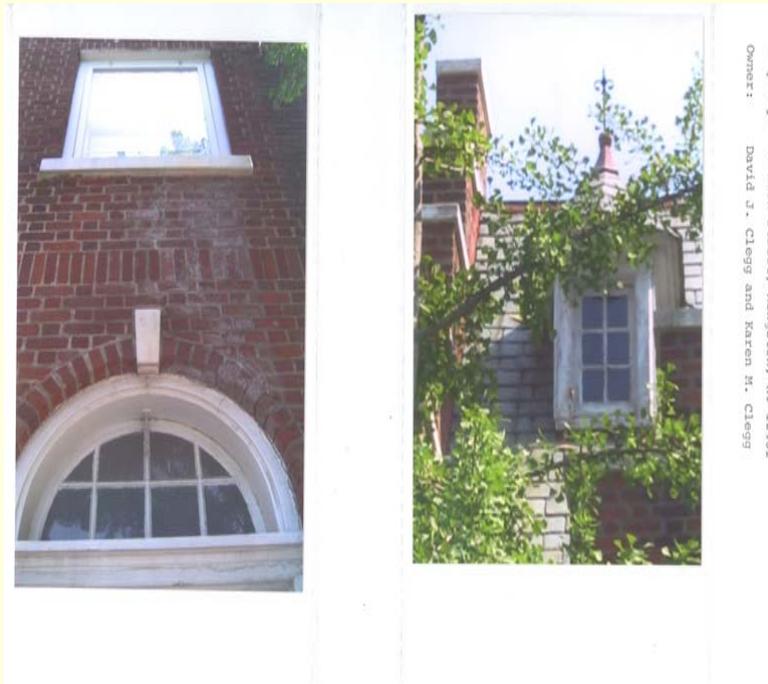
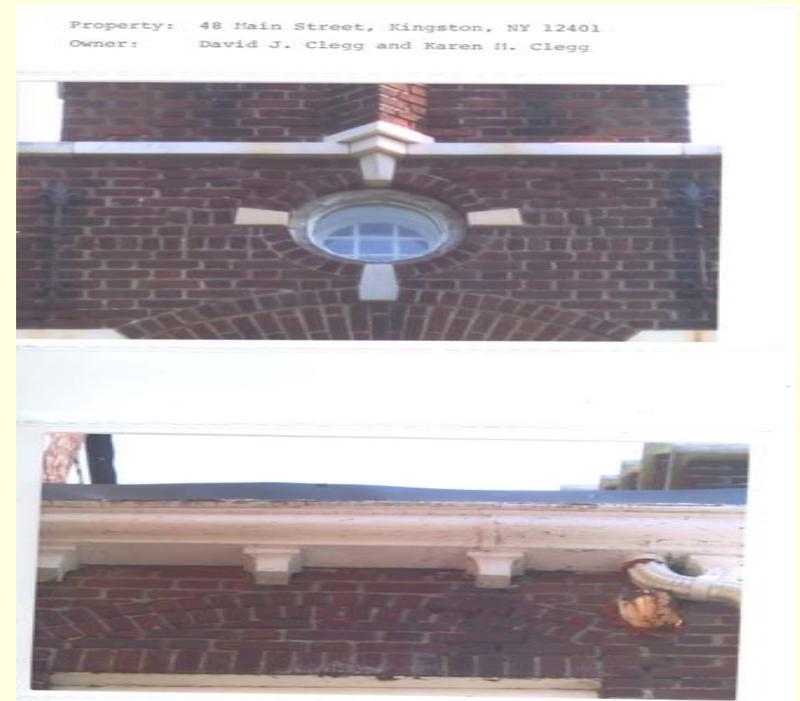
■ before

48 MAIN St.  
David J. Clegg Esq.  
Grant \$ 1,925.00 Owner Match 1,925.00  
Wood repair, scraping and painting

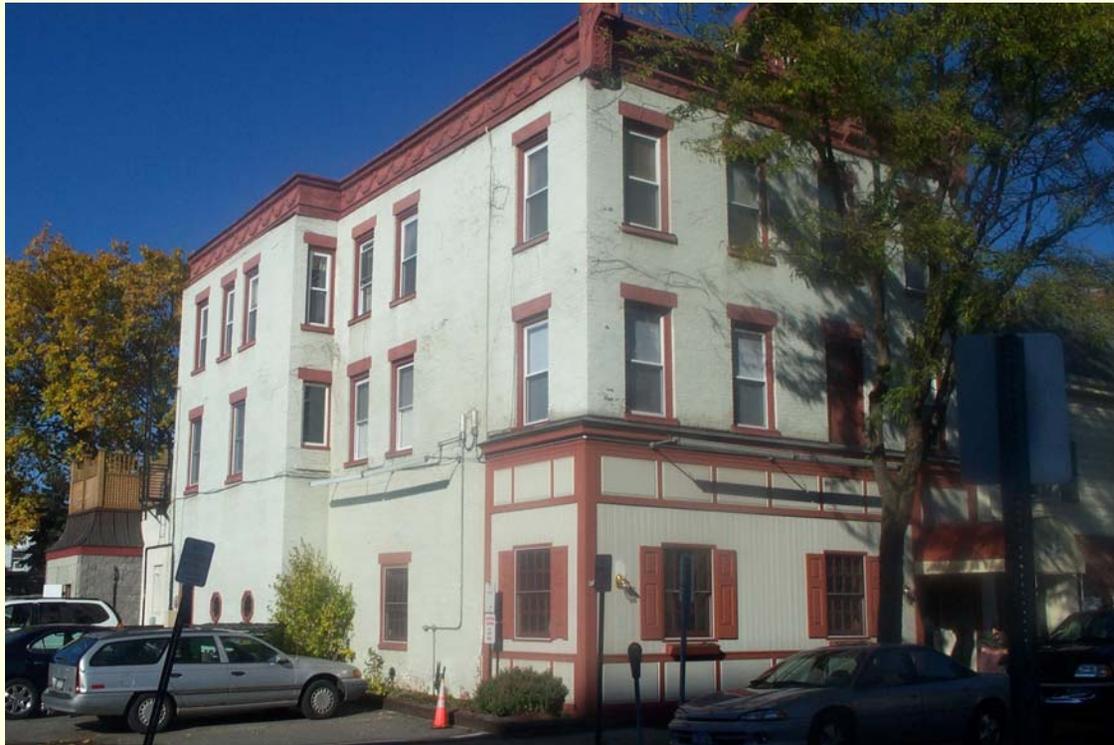
## ■ BEFORE

Masonry work, paint job

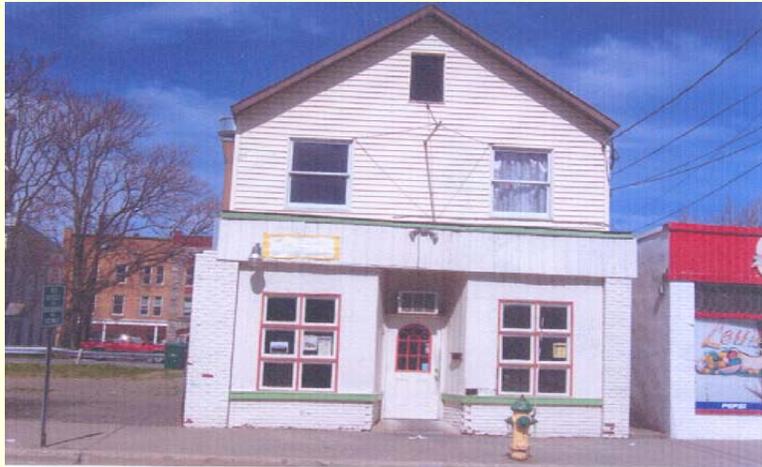
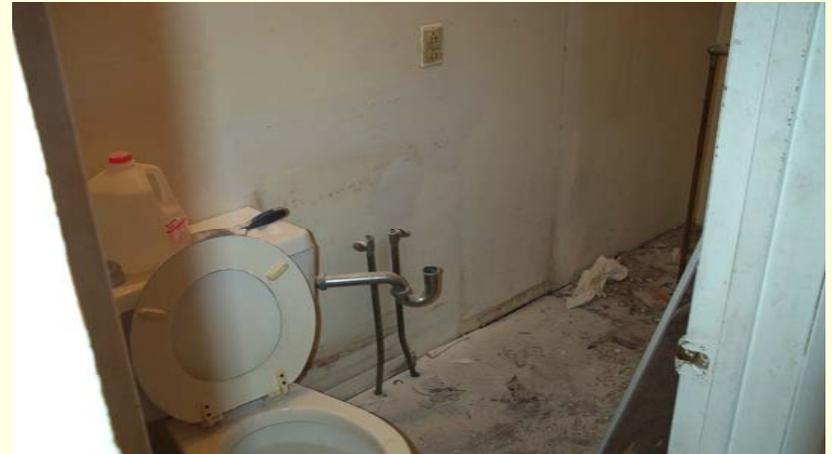
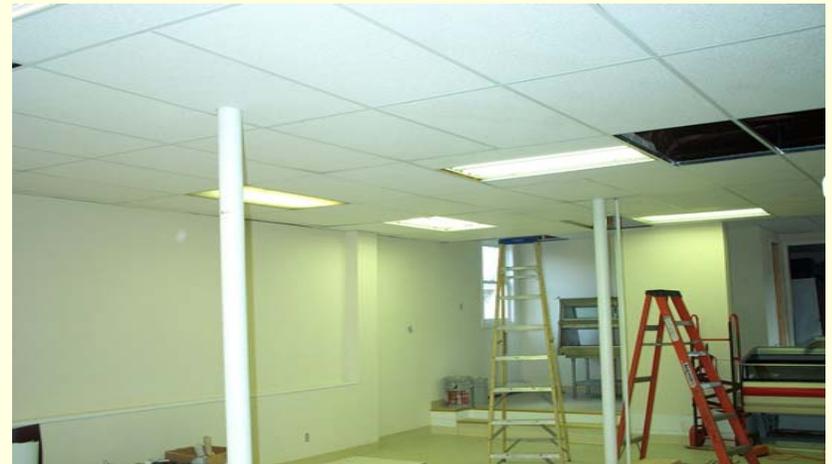
### ■ before

Façade renovations including new windows and commercial door, siding repair, sign installation, brick clean up and paint awning installation, lighting.
