# NY MAIN STREET PROGRAM

The Kirkland Hotel and Uptown Kingston

The uptown Kingston historic district is referred to as the Stockade District. Historical significance of the area dates to the revolutionary war period. Mall development in the town of Ulster over the last 30 years have aided to the decline in investment of retailers in this area. The following photos will be in tour order

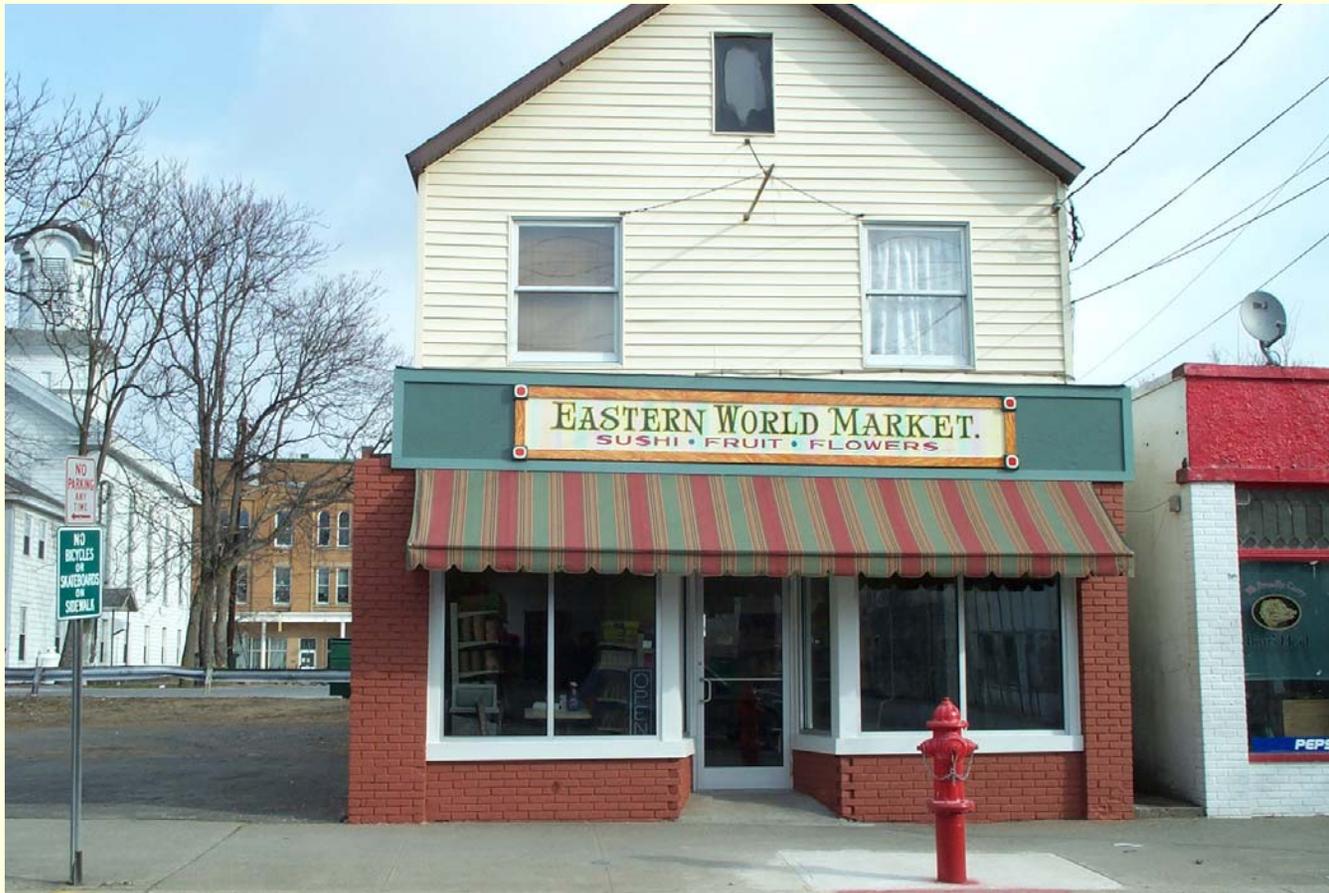
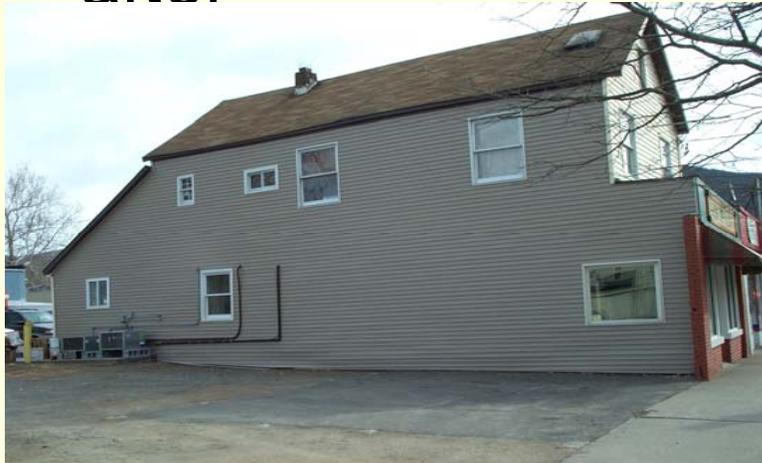
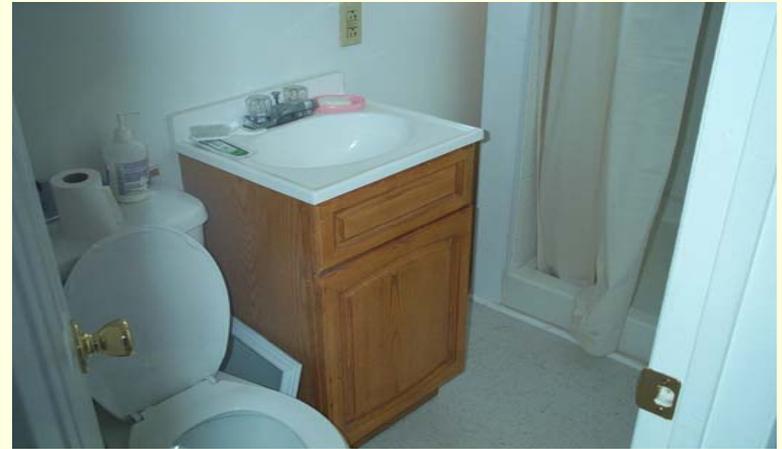
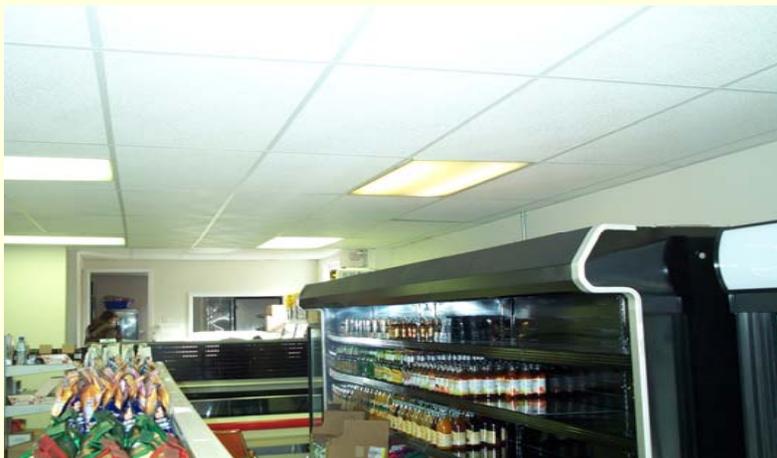
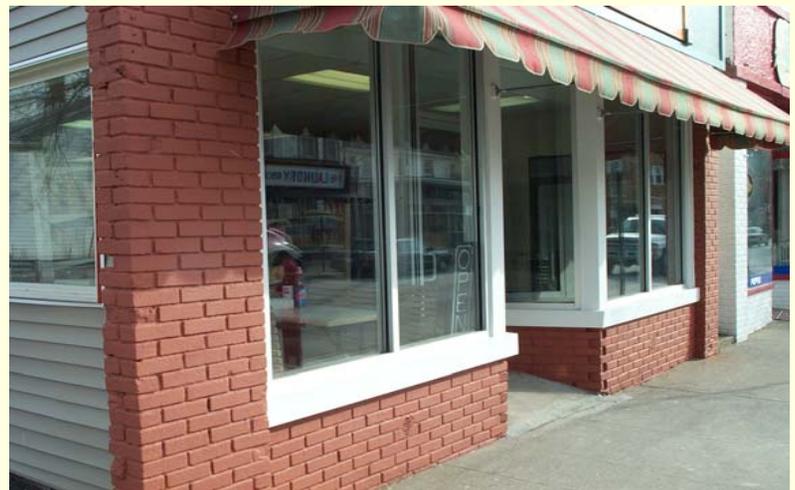
■ after

Façade renovations including new windows and commercial door, siding repair, sign installation, brick clean up and paint awning installation, lighting.

Interior work included renovation of entire interior to accommodate a new tenant opening sushi take out and some minor interior repair to upstairs residential dwelling.

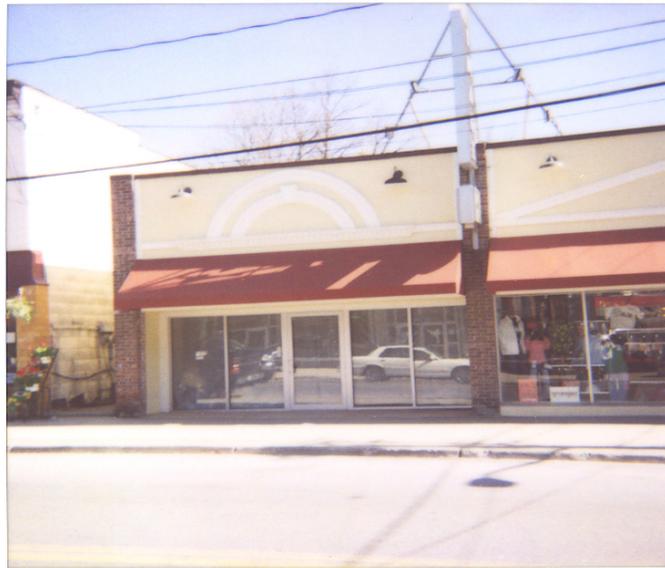
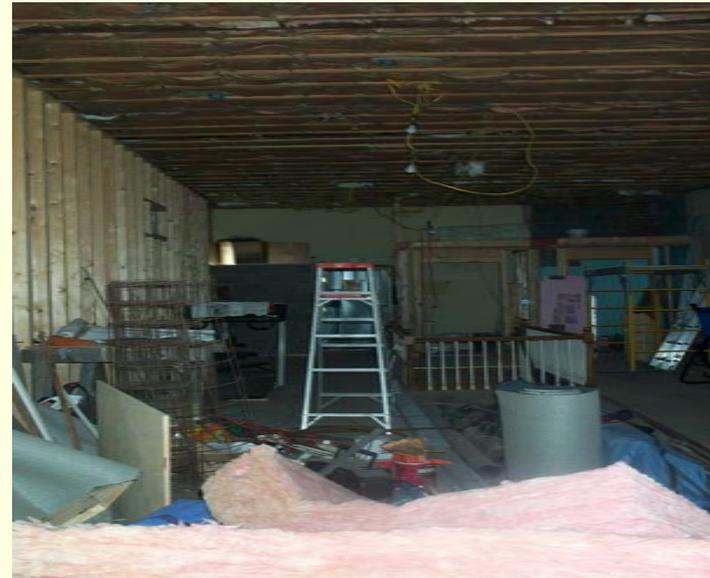
## ■ Before

The outside of the building including the owners popular quality clothing store on the right was previously renovated by the owner prior to application. The owner seeked assistance to finish store interior on left side including the installation of HVAC system. This space is going to be a tex-mex margherita café run by owners of property

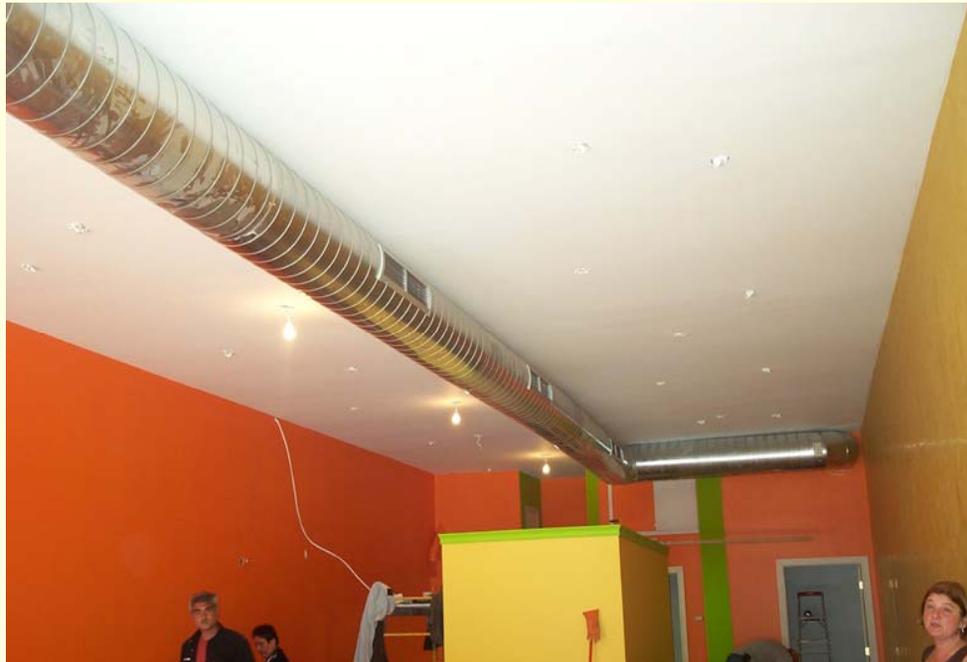
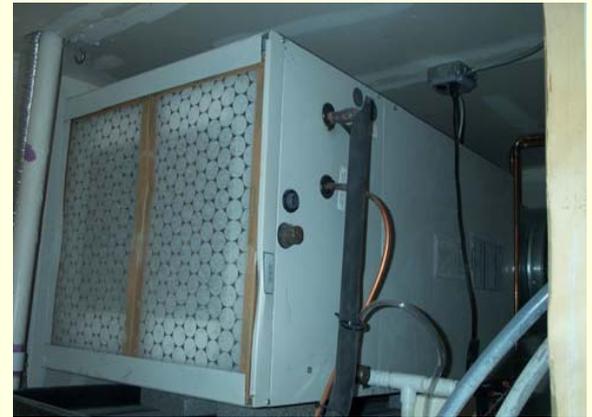
- After- new interior walls, insulation, heating and air system

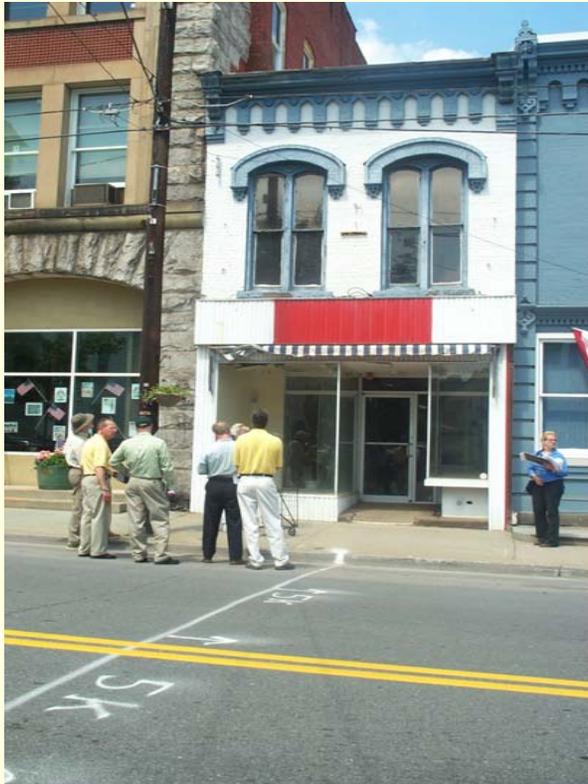
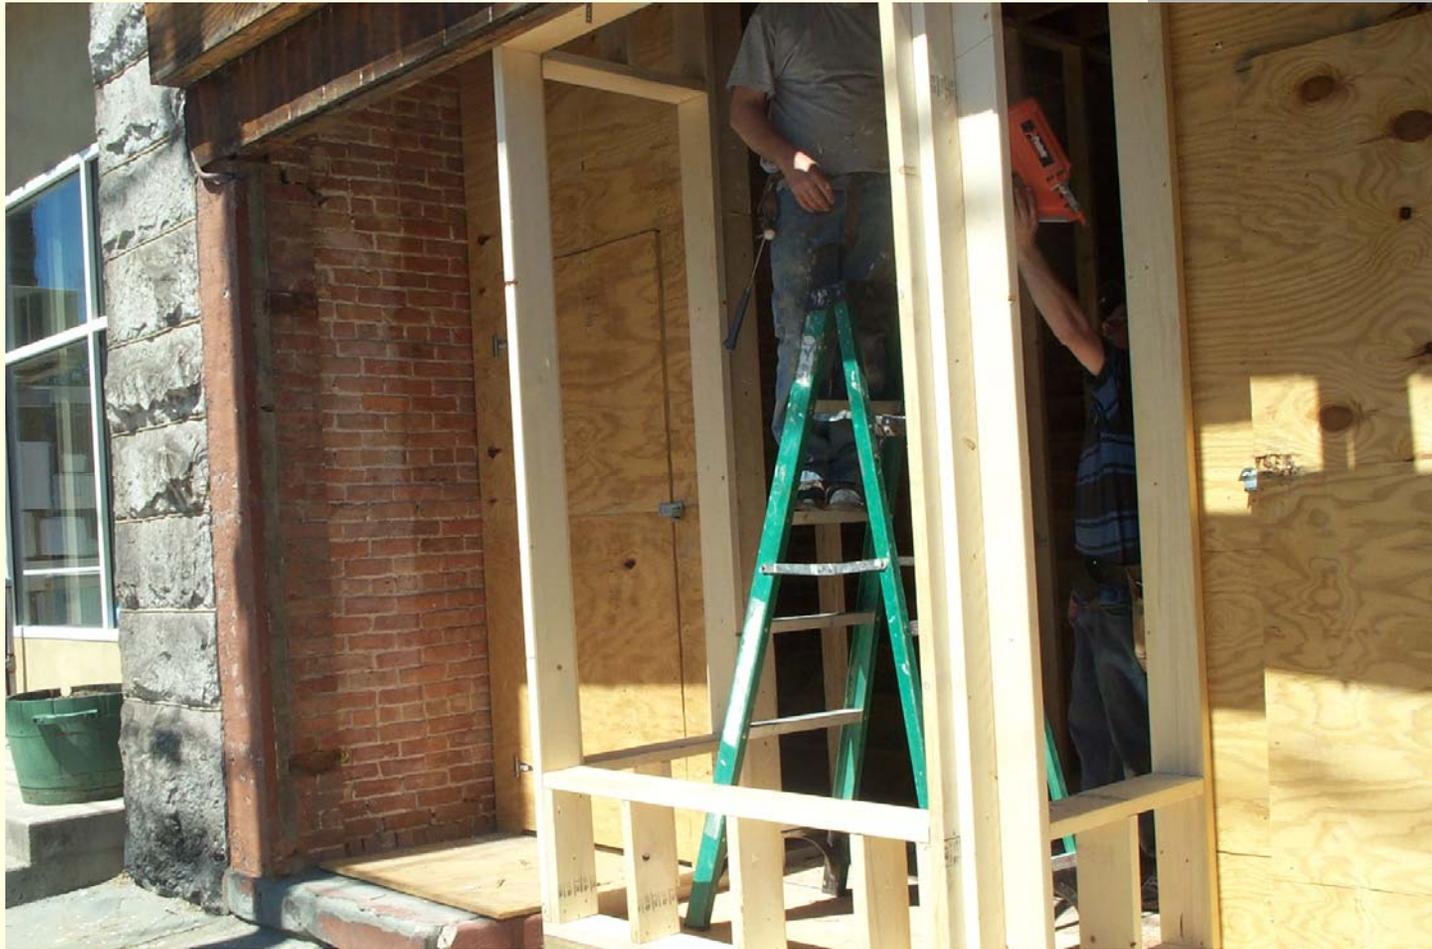
Restoration of exterior brick,removal of metal and old glass and doors .

Example of in progress work. Window openings and door heights are maintained.

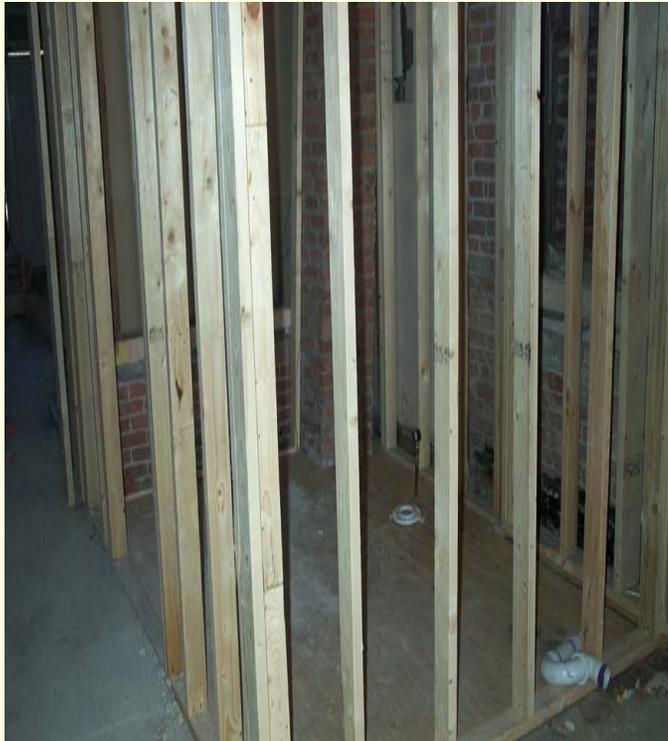
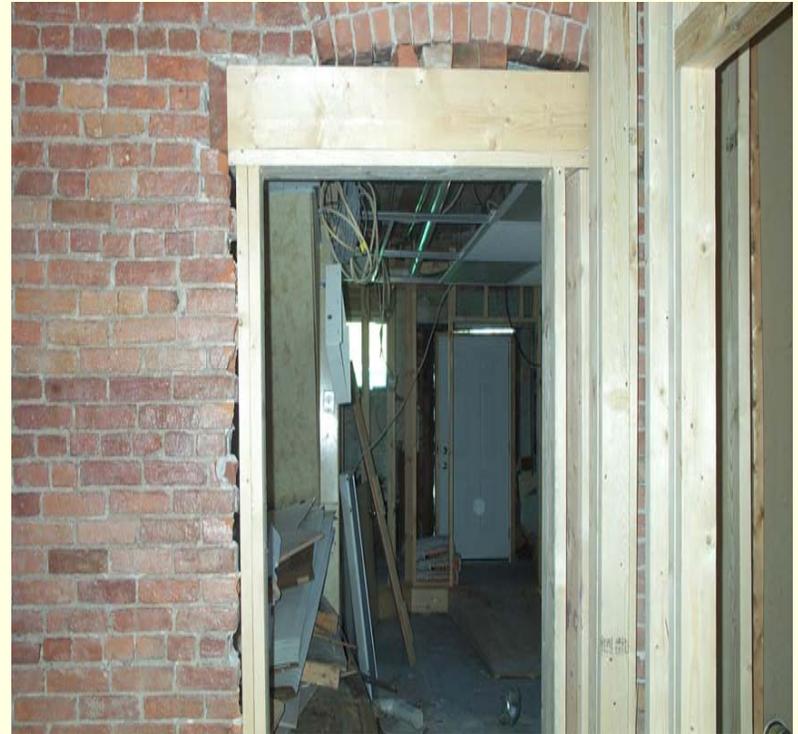
Accessible bathroom being erected-in progress  
Interior door reframing to widen for accessibility

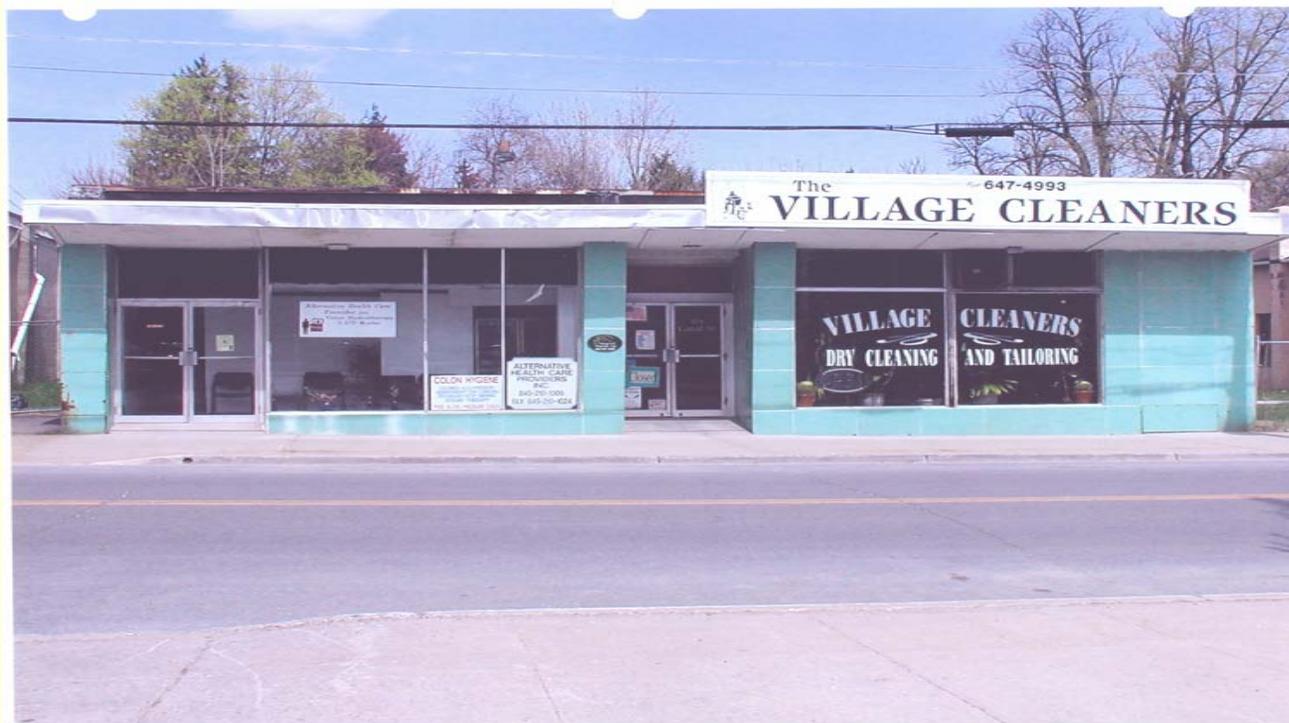
## ■ before

Remove all blue metal from building, erect a new façade knee wall on roof edge and stucco application to entire building

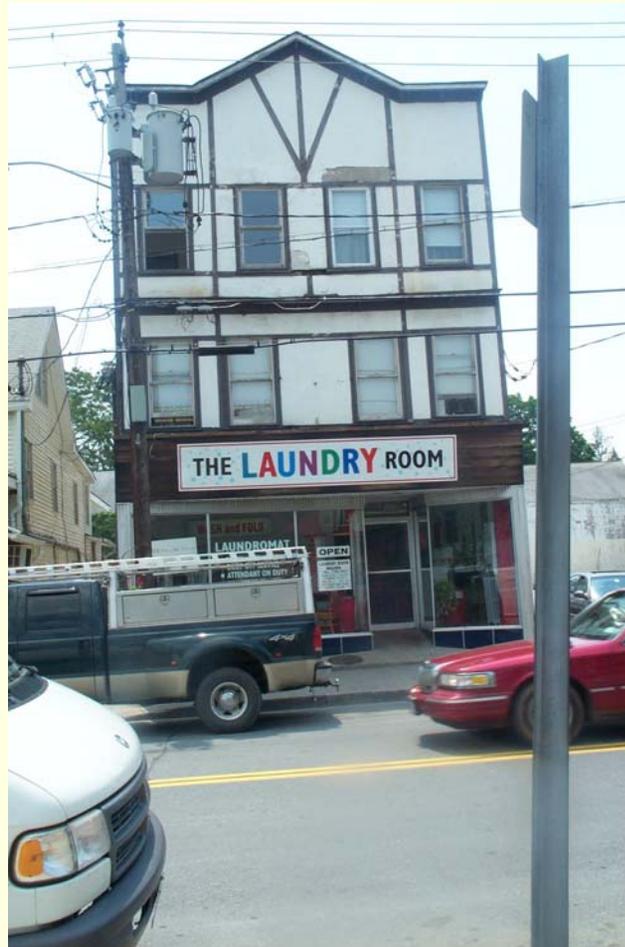
## Work in Progress

Grant award for façade \$ 7,500 Owner amount \$3550.00 ELDC \$1,000  
scraping and painting , wood repair ,

- Scraping and repair in progress

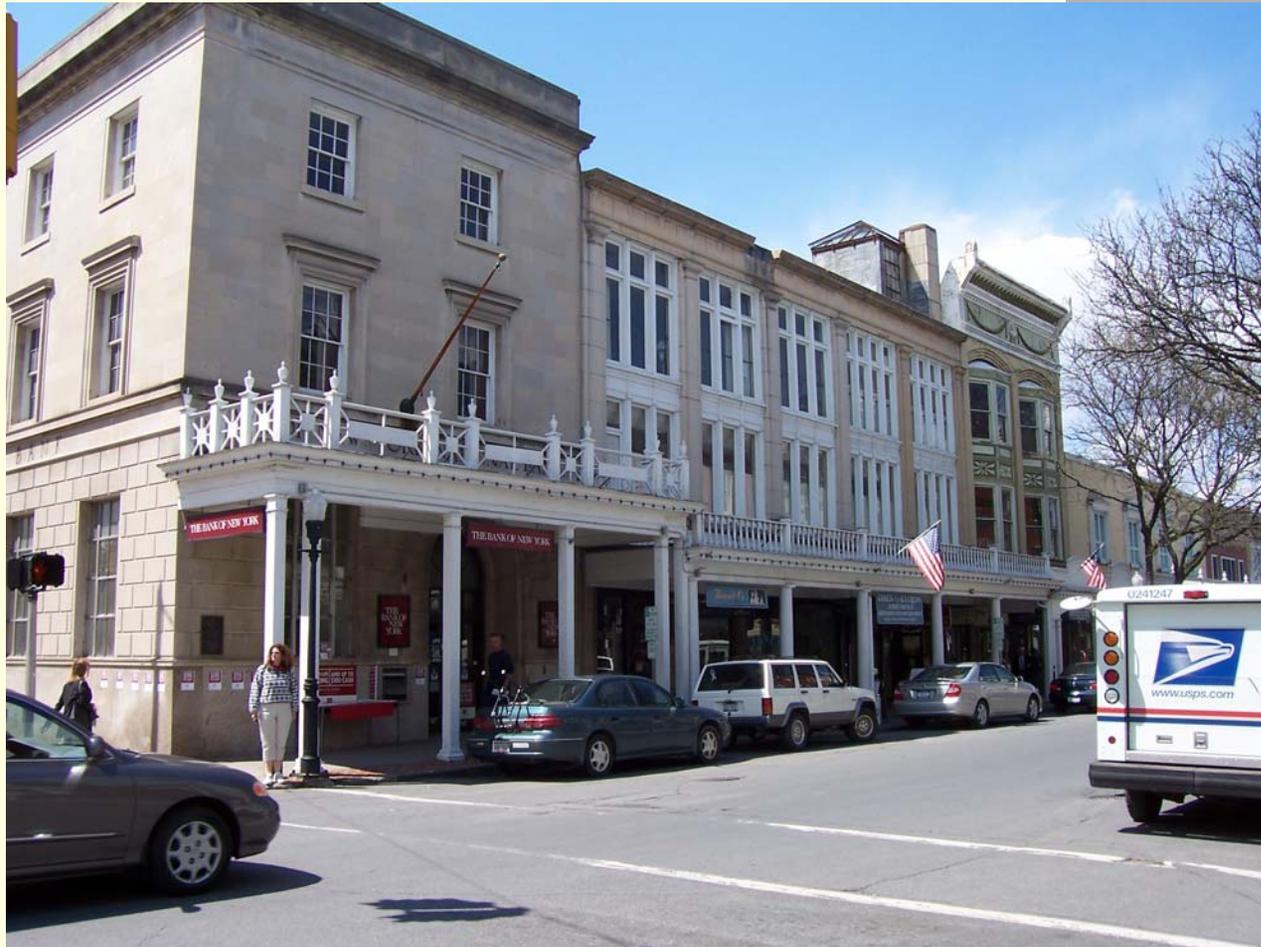
# Corner of Wall and John St.

- The following photos are a general representation of the Pike Plan in Uptown Kingston New York. Specifically defined as the covered walkways extending from the corner of Wall St. and John St. and extending to North Front Street to end at the Peace Park located on Crown St. This business district consists of a mixture of retail, restaurant, and office space with some limited residential dwellings. This covered walkway has added to the appeal of the uptown area since it's inception. It offers box planters which doubles as seating and is also the venue for many local events for which the streets are occasionally closed off. Continued Maintenance and Improvement of the Pike Plan is vital to the existing business environment and for potential growth of the area.

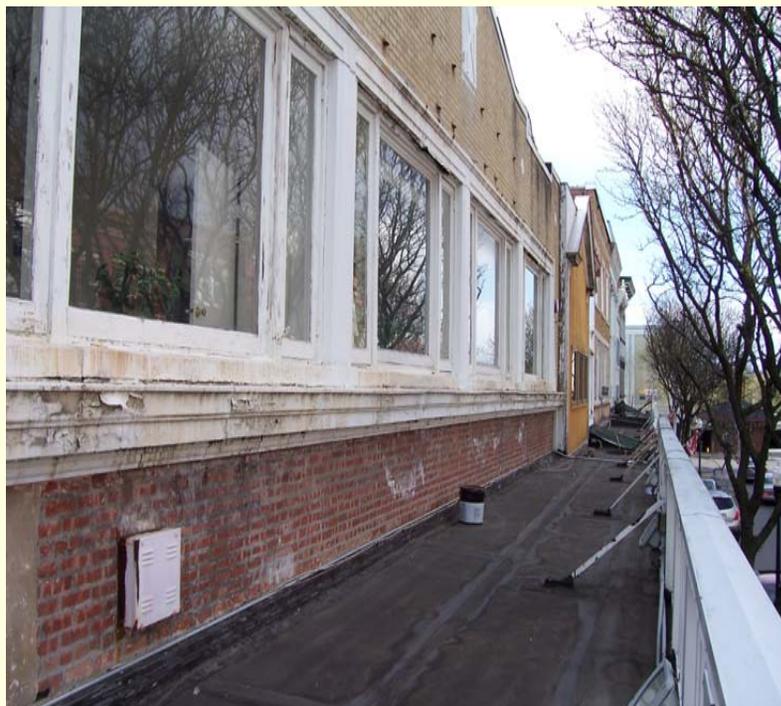
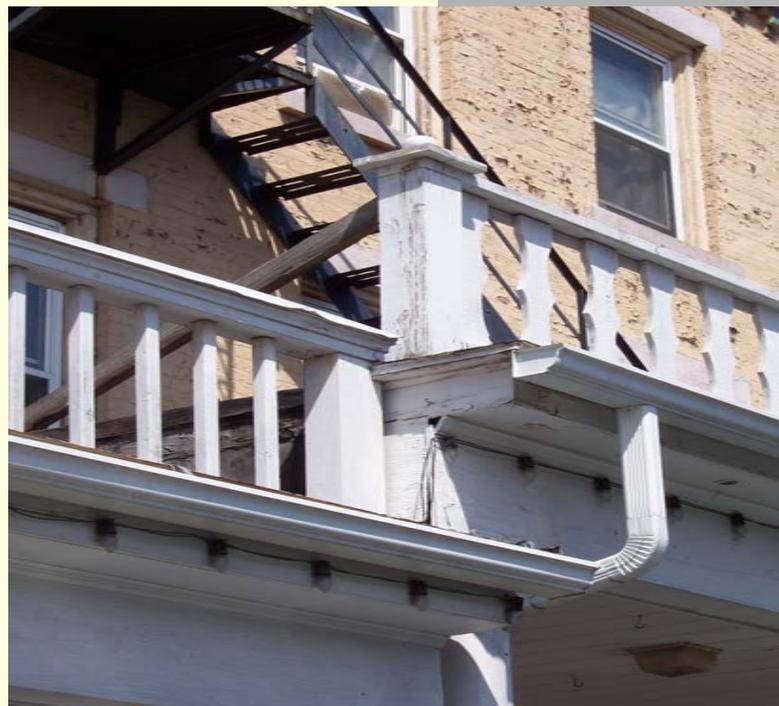
## Deteriorated paint on upper buildings and railings

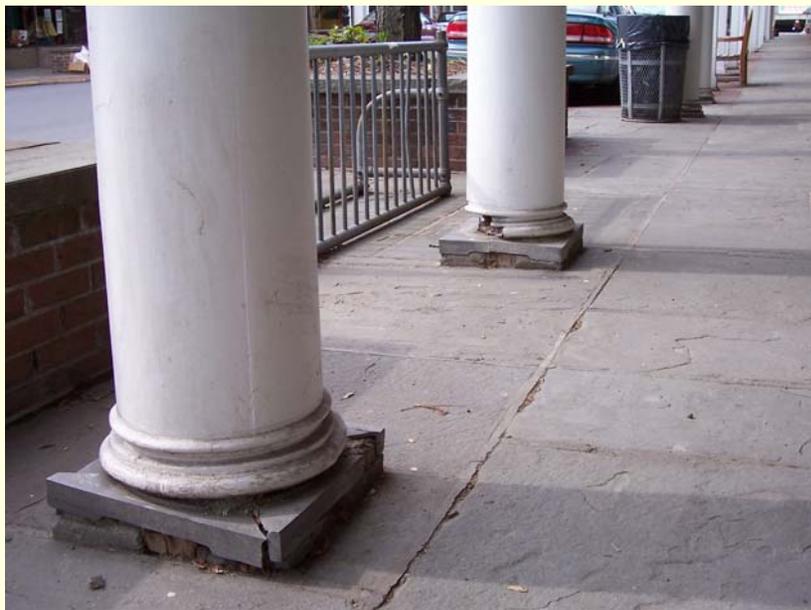
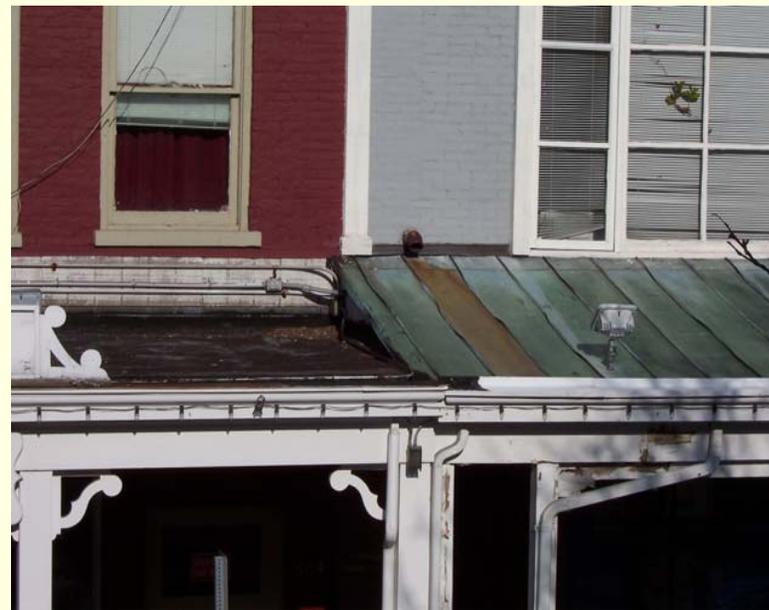
Column bases and footings are crumbling in need of repair or replacement

Uneven transitions between composite and metal roofing with leaking areas

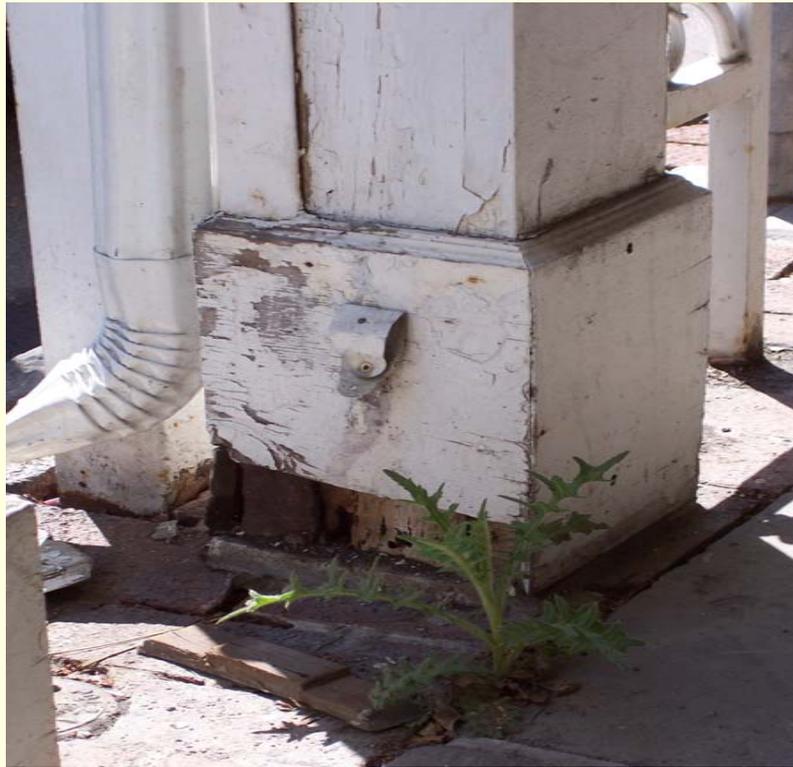
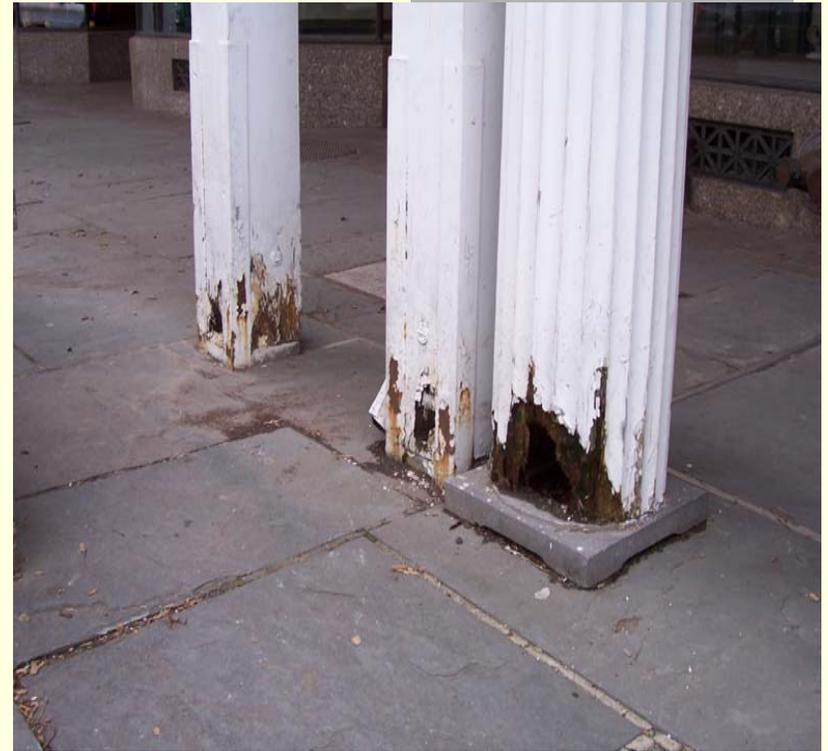
Rotted stock and fluted columns in need of new bases or replacement and gutter/leader service to roofs must be redesigned to improve run off and diversion of water from structures

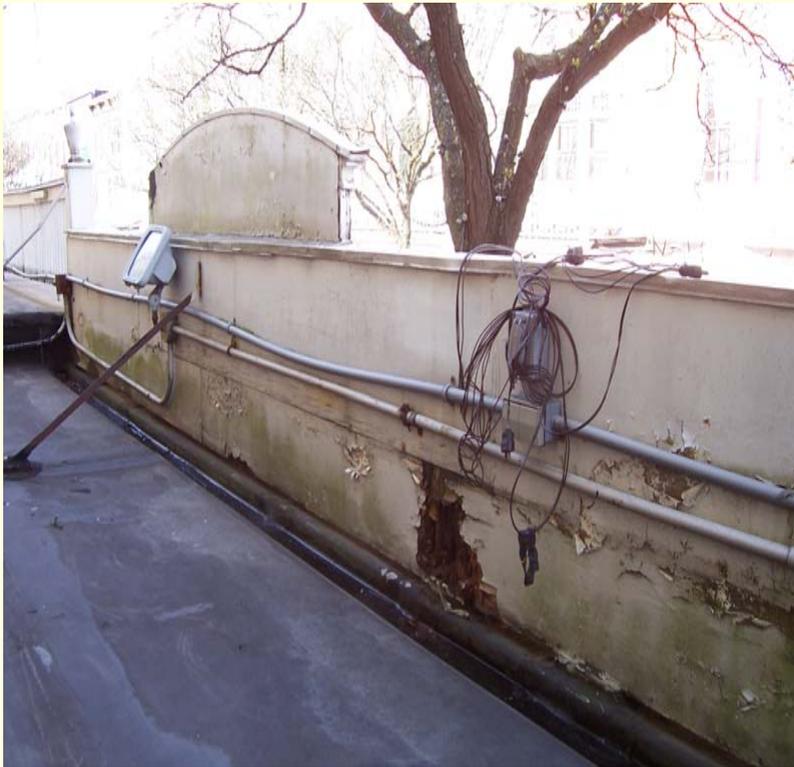
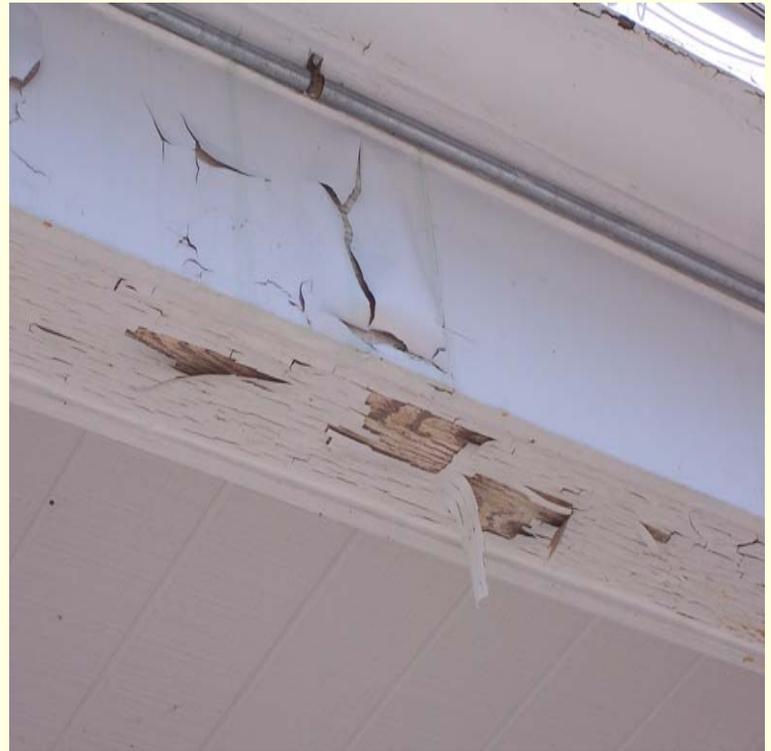
Most façade backs are at their limited life use and are seriously deteriorated ,electrical issues also exist due to years of layered changes. Most Soffits and fascias are in need of painting or replacement

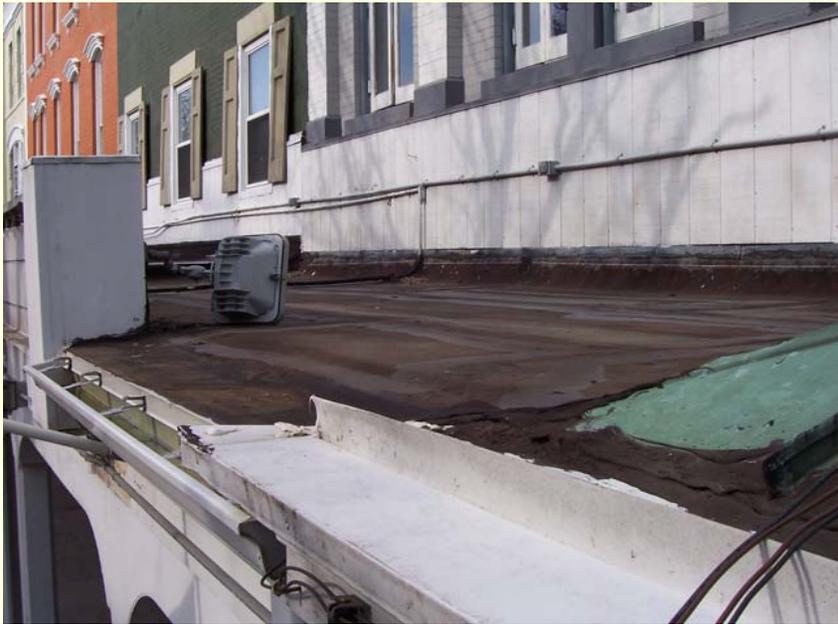
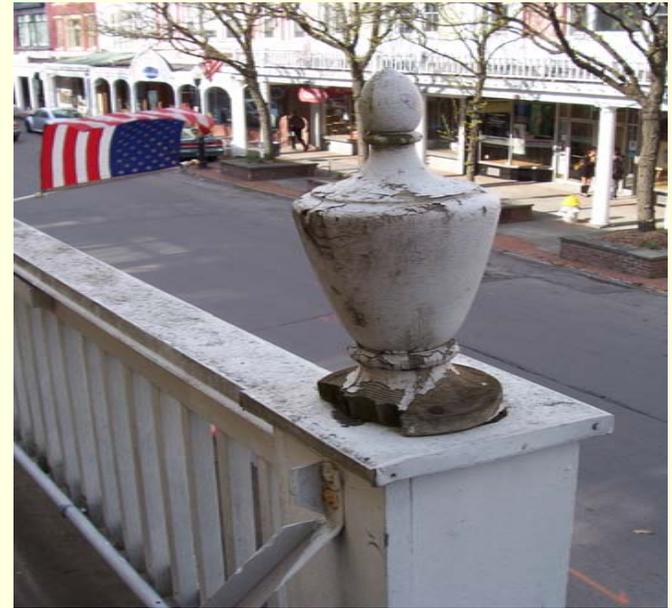
Replacement of the architectural design elements are needed

Existing flat roofs may need to be considered to be rebuilt with a pitch, less problems have been noted with the pitched roof areas, also to achieve continuity. Flat roofs should be properly joisted to handle loads with safety railings to possibly utilize balcony space to increase second story usage.
