## Historical Buildings A Holistic Approach to “Green”

New York State Office of Parks, Recreation and Historic Preservation

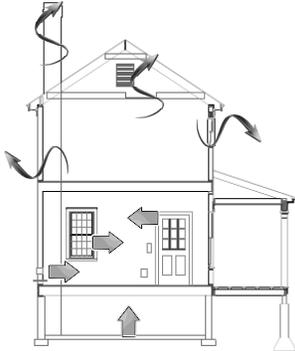
## Common Air Leaks – Stack Effect

- CHIMNEY
- ATTIC HATCH
- WINDOWS
- OUTLETS
- UTILITY ENTRANCES
- DOORS/WINDOWS
- DRAINS
- CRACKS

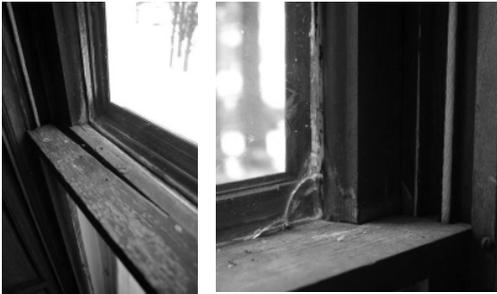
## Air Infiltration at Windows

A Weather-stripping should be installed at the jambs, the sill, the head and at the meeting rails. Use a thin putty knife to slip behind the stop and lightly pry off.

B Spring bronze is a good choice for the jambs. The strip is nailed to the jamb channel along the interior side at the stop or parting bead.

C An interlocking strip is best for the meeting rails. When the window is closed, the strips close off any air gaps. The sash lock pulls the meeting rails tight.

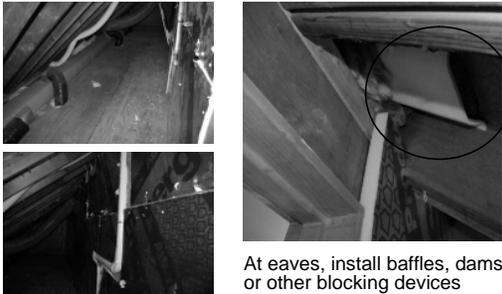
## Unfinished Attic Spaces

At eaves, install baffles, dams or other blocking devices

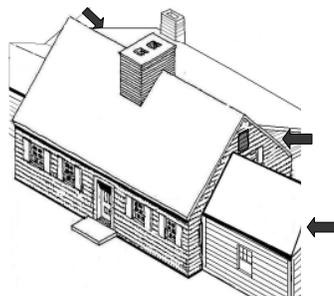
## Attic Venting

- Install insulation over the attic floor and over the attic hatch. Rigid insulation should be placed over the attic hatch
- Attic vents need to be clear for proper air movement and drying.
- If you must install new attic vents in the gable end, consider how this will alter the historic appearance of your building and avoid irreversible changes.

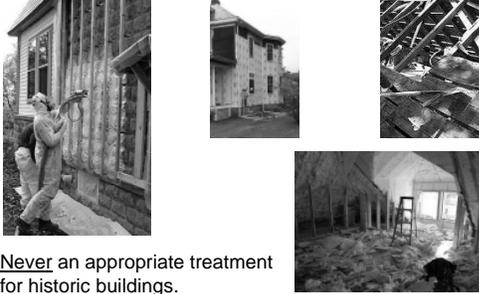
## Deep Energy Retrofits

Never an appropriate treatment for historic buildings.

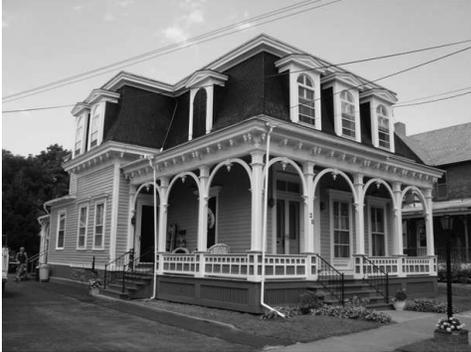
## Rehabilitation & Lead Abatement

- Install interior and exterior storm windows
- Install exterior storm doors while retaining original doors. Weather-strip doors & windows
- Remove lead paint
- Insulate attic
- Repair cornice – water issues
